# **Construction of Artificial Fish Habitat in the Englishman River, 2004**

**M.P. McCulloch  
Fisheries Technician  
Greater Georgia Basin Steelhead Recovery Plan  
BC Conservation Foundation  
Nanaimo, BC**

**January 2005**

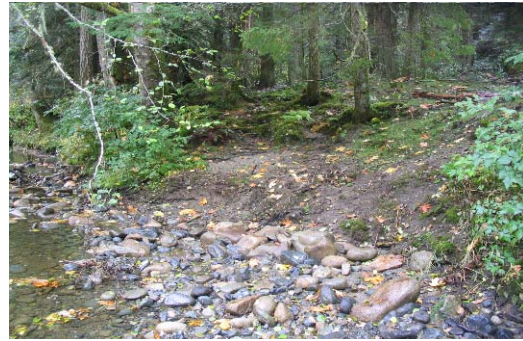
Photo 2. Looking at lowermost access near 3+800 after deactivation.

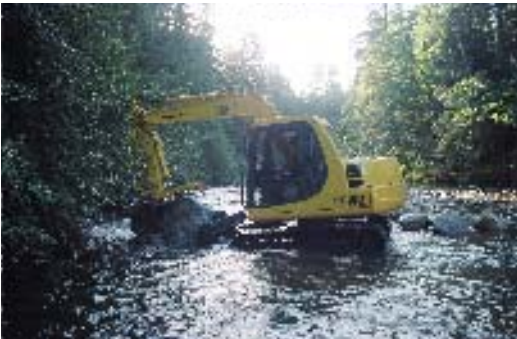
Photo 3. Small excavator placing rocks at riffle site 3+800.

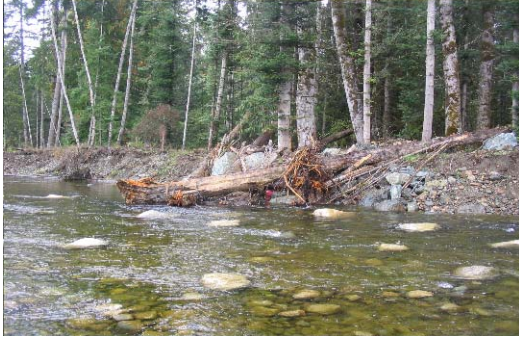
Photo 9. Looking downstream at site 5+730 with riffle 5+800 in foreground.

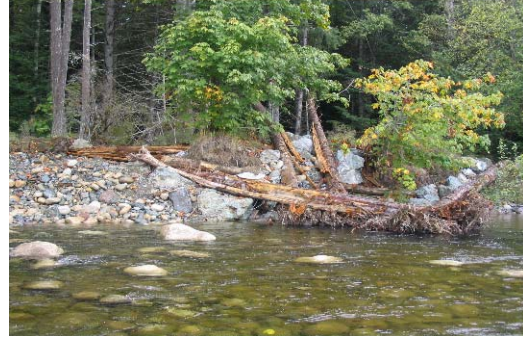
Photo 10. Looking across-stream at site 6+080 post-construction.

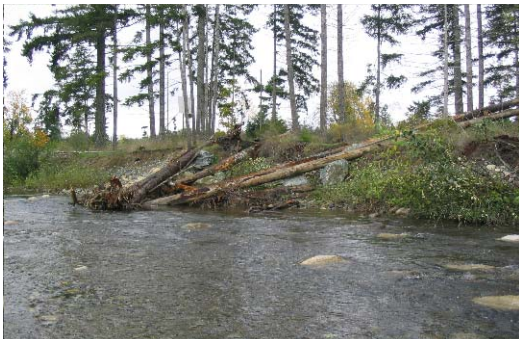
Photo 13. Looking across stream at site 6+260 post-construction.

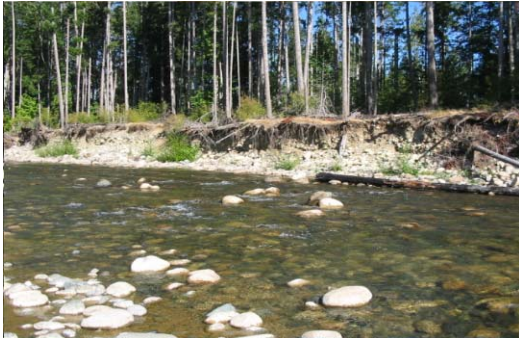
Photo 17. Looking upstream at site 7+180 pre-construction.

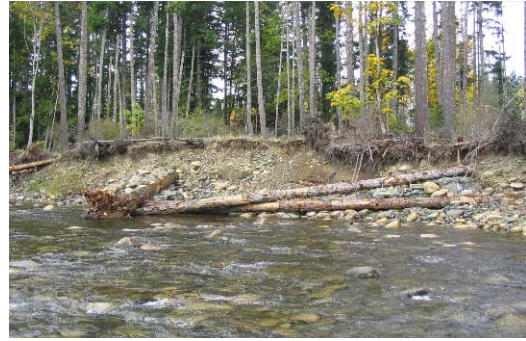
Photo 18. Looking downstream at site 7+180 post-construction.

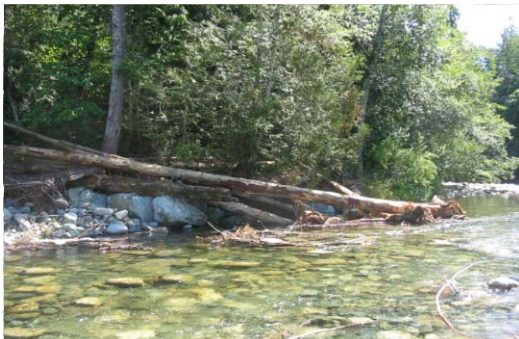
Photo 21. Looking downstream at site 8+790 post-construction.

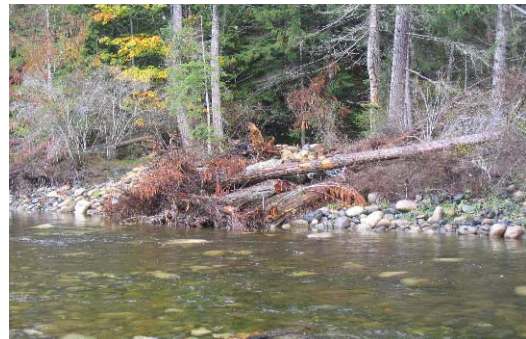
Photo 22. Looking upstream at site 8+805 post-construction.
