Fish Habitat Rehabilitation in the Englishman River, 2006

S.W. Silvestri Fisheries Biologist BC Conservation Foundation Greater Georgia Basin Steelhead Recovery Plan

August 2007

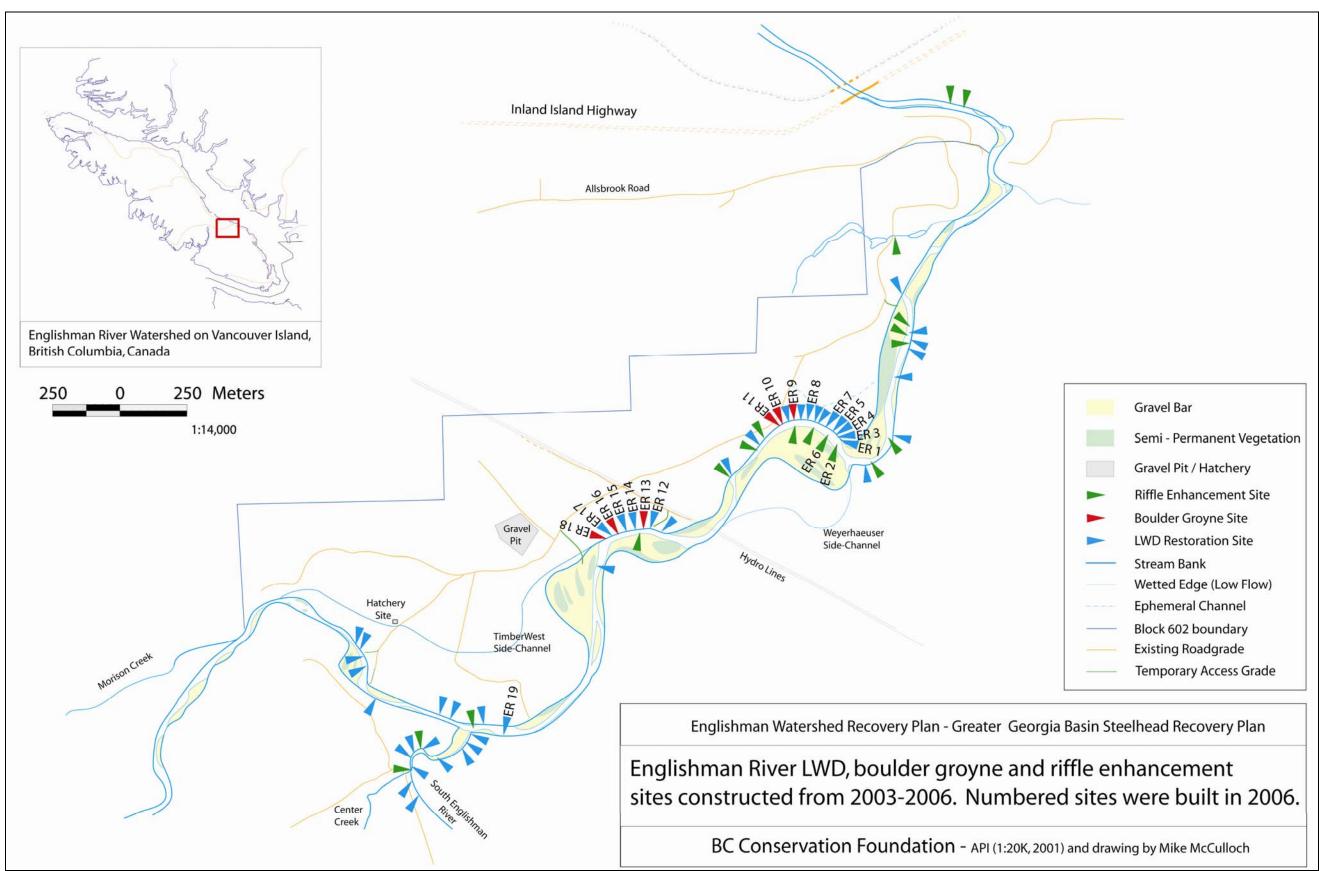
Figure 3. Location of fish habitat restoration sites constructed in the Englishman River, 2006.

A total of six new LWD sites, six boulder groynes and two boulder-riffle enhancement sites were constructed in six and a half days from July 19-27, 2006 (Figure 3; Appendix B, Photos 7-8; Appendix D). Additionally, five previously constructed LWD site were enhanced with additional wood and rock to increase complexity and reduce site porosity.

Post construction monitoring of all sites constructed occurred throughout the fall and winter following high water. On November 15, 2006 a large rain on snow event in the upper Englishman River watershed resulted in a significant one in ten year flood event in the lower river (un-corrected peak discharge near 550 m³/s). In total, six LWD structures were displaced, while four other LWD sites were significantly damaged. Maintenance works to repair or replace these structures will be scheduled for the summer of 2007

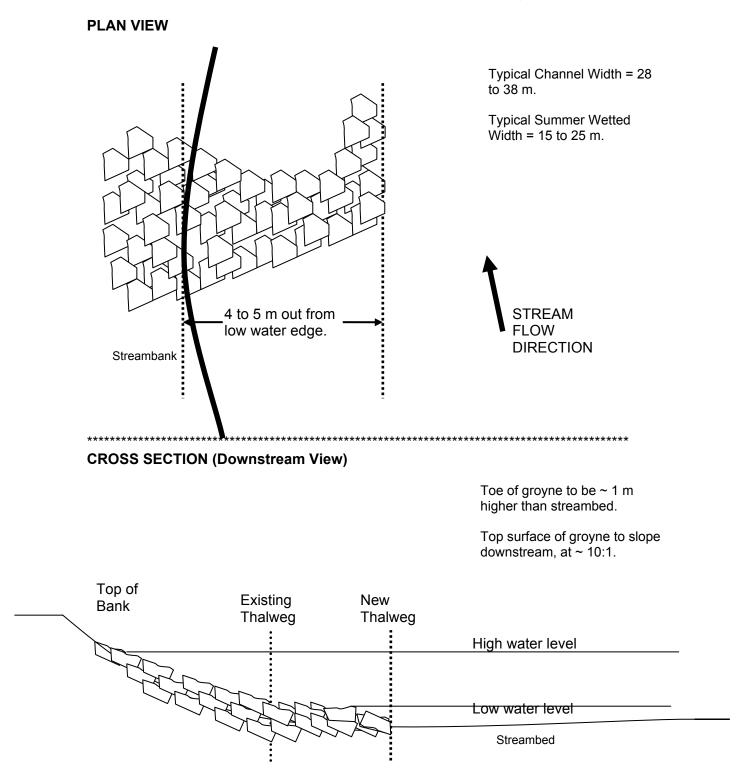
Englishman River, 2006 Template – Low Profile Boulder Groyne

Rock deflector structures were created at identified sites using the same equipment. Large boulder pieces were keyed into the stream bed, with additional rock placed on top to a specific height. Deflector structures were constructed with low profiles to provide the required protection and minimize hydraulic disturbance (Appendix C).
