Vancouver Island Riparian Restoration Recommendations and Prescriptions – Quinsam, Chemainus, Englishman, Little Qualicum, and Oyster Rivers

V.A. Poulin, R.P.Bio., A.Sc.For.
V.A. Poulin & Associates Ltd.
2153 West 46th Avenue,
Vancouver, BC
V6M 2L2
Email: vpoulin@shaw.ca
Phone: (604) 263-0424

BC Conservation Foundation
Nanaimo, British Columbia

January 2005

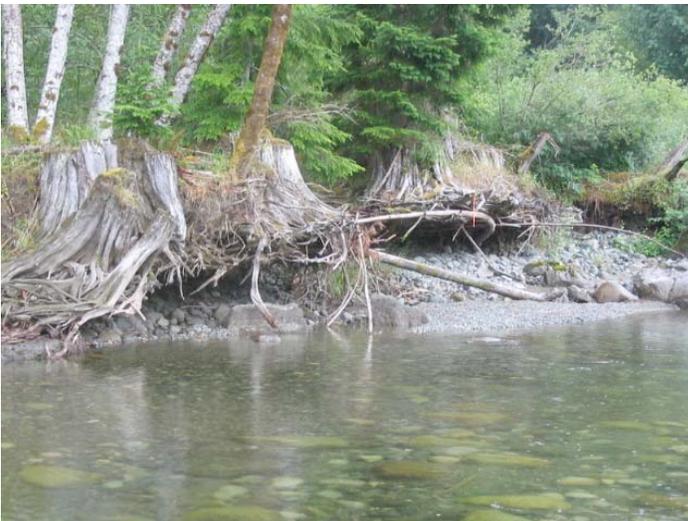
Figure 1 legacy Douglas fir stumps on the Chemainus River

they made a statement. Their large size spans channels or anchors solidly. Their wide lateral roots hold long sections of stream bank together maintaining channel width and retaining flushing flows. These processes were operating on all the rivers assessed prior to development. It doesn't take much imagination to see the difference, but a picture is worth a thousand words (Figure 1).

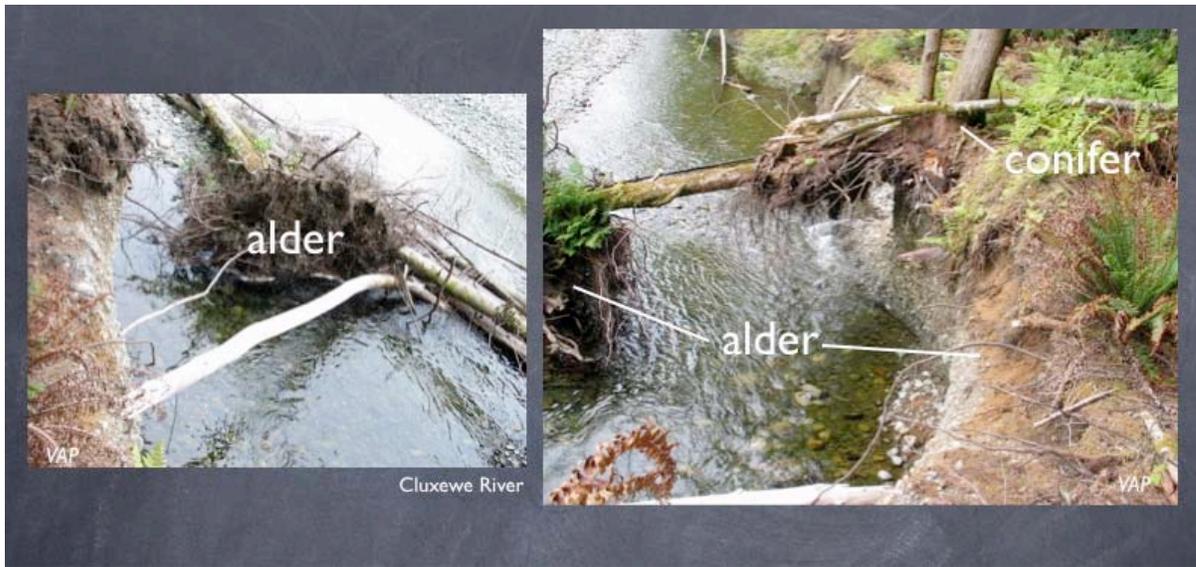
Figure 4 bank erosion caused by alder toppling

Vegetation is Mother Nature’s defense against erosion. The roots of trees form mats that bind stream banks and floodplains together and ensure water velocities remain high within channels making it possible for a river to flush excess sediment. Not all trees do this well. Short-lived deciduous trees are weak and rip-out when only moderately undercut by erosion. The “weakest” and most problematic of all riparian trees is alder. Alder grows intensely on disturbed sites often achieving densities of 600 - 1200 stems per hectare. Growth is rapid. Once above the height of seedling conifers their tops fill the sky closing off light to the smaller trees. Starved of light seedling conifers grow slowly, many die if not established on good growing sites. Alder are not long-lived. From Campbell River south they begin to die at 40 years, but can live to 60 - 80 years. Alder are effective nitrogen producers; their litter helps build floodplain soils and it contributes organic material to fish food production. However, critical to fish habitat protection and restoration is the damage they do. The sediment added from bank erosion caused by alder toppling increases bed load, gravel scour, deposition and ultimately exacerbates channel widening. The process is seen in nearly every major coast river system and is a serious problem in all of the rivers assessed. Once in rivers the size of those assessed alder debris is not stable. It is usually

washed out or jams forming temporary structures that more often than not causes additional erosion and bank loss. These factors are a serious impediment to watershed restoration and so much so they far out weight the ecological benefit it provides. Conifer suppression, alder jams, avulsions and wholesale channel widening are in the opinion of this author the leading impediments to the rebuilding of salmon and steelhead stocks virtually coast wide.

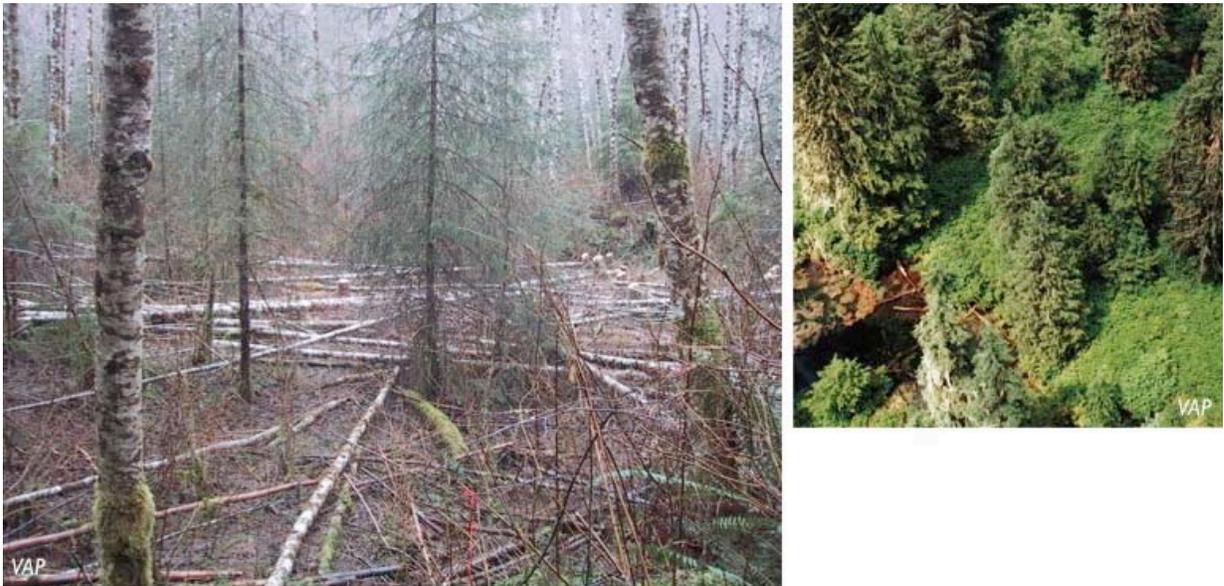
Figure 6 conifer release

The trees in figure 6 were felled by chain saw. Felled trees were left on the floodplain. In areas where alder stands contain trees of adequate size to harvest partnering with a timber harvesting to remove the trees is recommended. Conifer release treatments have wide application by volunteer groups where girdling is acceptable. Trees are girdled using either a chain saw or hand tool. Hand tools are suitable for all diameters of alder, but larger trees are more easily handled by chain saw. Small diameter alder cut with a chain saw can

The right image in Figure 6 shows the end result of a conifer release treatment. In this case the trees in the image are conifers released naturally when alder died-off. The condition of any future stand is dependant on the composition of the understory trees present at the time of treatment. Conifer release treatments are specified for stands where moderate understory conifer are already in an advanced state of regeneration. Overstory removal leaves these trees in the mix already established through natural regeneration, but better assures the stand will meet the desired future condition by reducing mortality and improving growth of released trees.

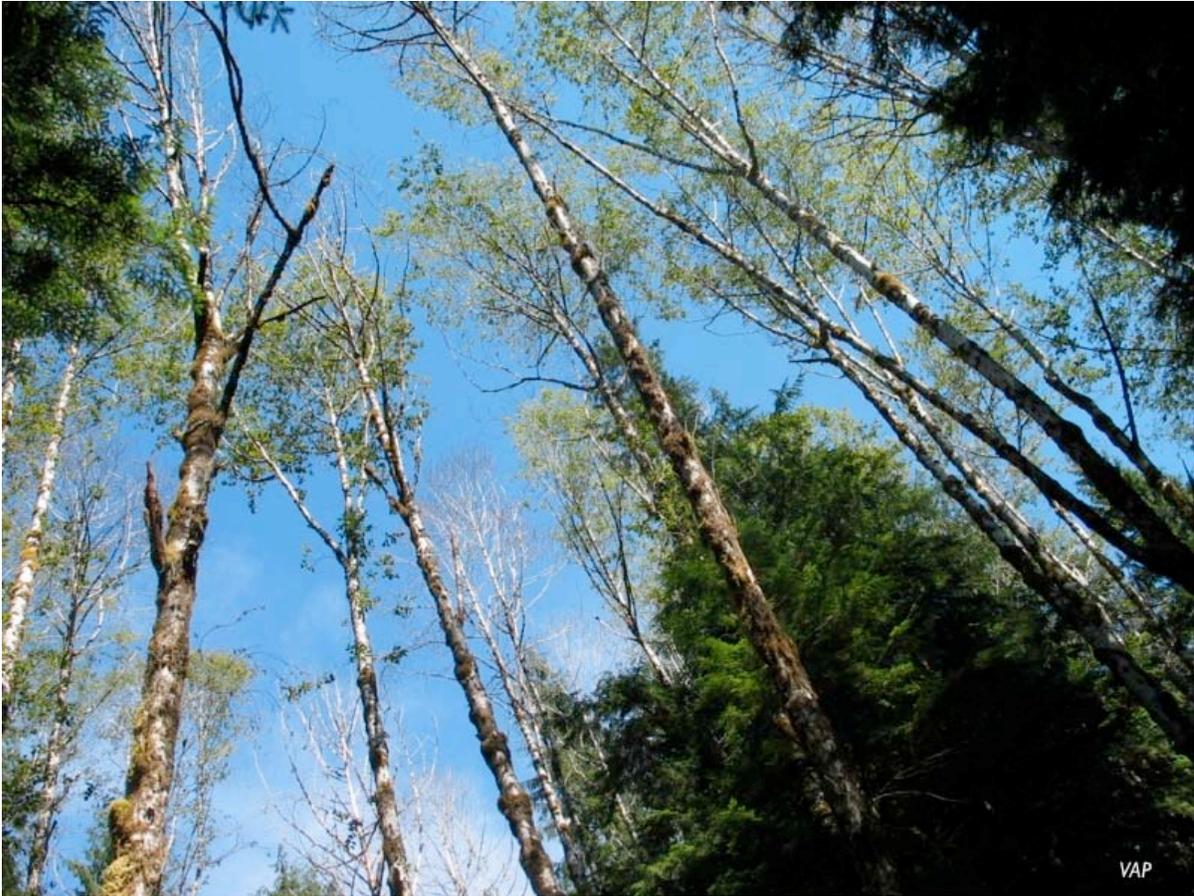
Figure 7 girdled alders 4.5 years after treatment

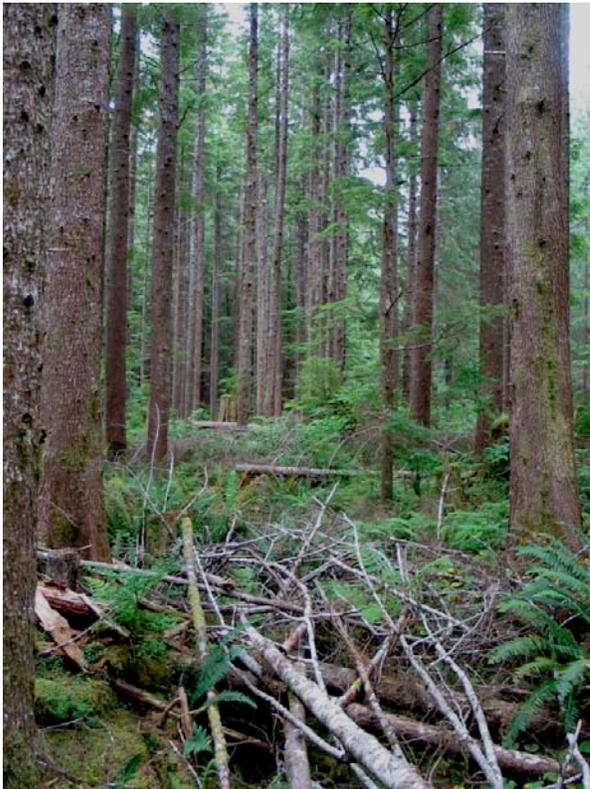
Figure 8 thinned conifer stand (UT)

Thinning requires felling. It is not fully determined at this time whether the new requirements for certified fallers will apply to spacers, but the suggestion is all spacers cutting trees over 15 cm dbh must be certified fallers. It is fair to assume that all of the conifer stands specified for thinning will likely have to be done by certified crews. This should not discourage BCCF from pursuing thinning as a strategic treatment. The benefits acquired from thinning are very high given well spaced riparian trees on productive sites

can achieve radial growth rates of 6 – 12 mm per year (0.5 to 1 inch in diameter) and become exposed to wind at an early age. Exposure to wind strengthens stems and stimulates increases in diameter (Whitcomb 2000).

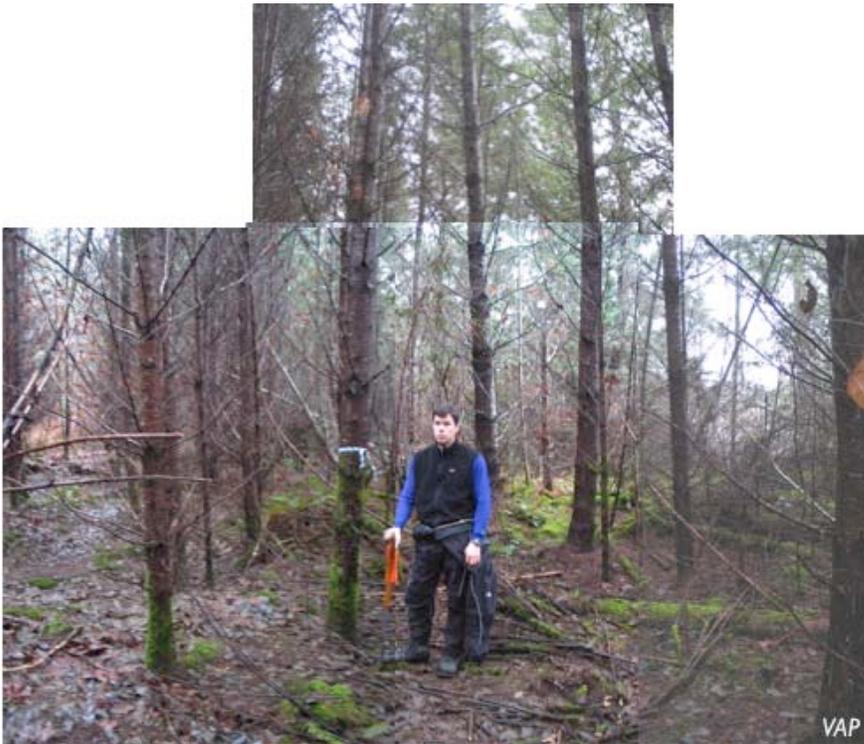
Figure 9 over-stocked conifer stand Polygon 13 on Englishman River

Uniform thinning is recommended for polygons 6, 11, and 13 on the Englishman River (Figure 9). Uniform thinning retains the greatest number of stems per unit area on a site and better allows for phased use of trees over time. The entry prescribed is to remove excessive stocking now, but allow for subsequent entry at a later date when trees are of a size for use in reconstruction of fish habitat structures. Polygon 13 contains a sampled stand. Stocking was uniformly Douglas fir at 1300 sph. Mature grand fir, western red cedar and Douglas fir form a thread-like outer boundary of the polygon along the river, but the majority of the polygon is a 1976 Douglas fir plantation. Polygons 6 and 11 are similar dense stands.

Polygons 6 and 11 were not traversed, but appear from the river to be suitable for thinning to 600 – 800 sph. Polygon 13 can be thinned to 500 – 600 with adequate trees retained for future use. It is generally recommended in riparian restoration to retain the largest diameter trees present on a site, but in situations where fish habitat reconstruction efforts are ongoing in the watershed removing some of the largest diameter trees while replacing them with healthy smaller trees is a viable and highly recommended option to reduce restoration costs. Plot 1 in polygon 13 demonstrates this option. The largest trees in the plot are 30 and 35 cm dbh, both have demonstrated good growth since planting and are the dominant trees. Thinning to 500 sph requires the removal of 8 trees in the plot. By utilizing the two largest trees for fish habitat reconstruction two of the 8 trees normally felled would be retained to replace the two largest taken. The concept is similar to pre-commercial thinning.

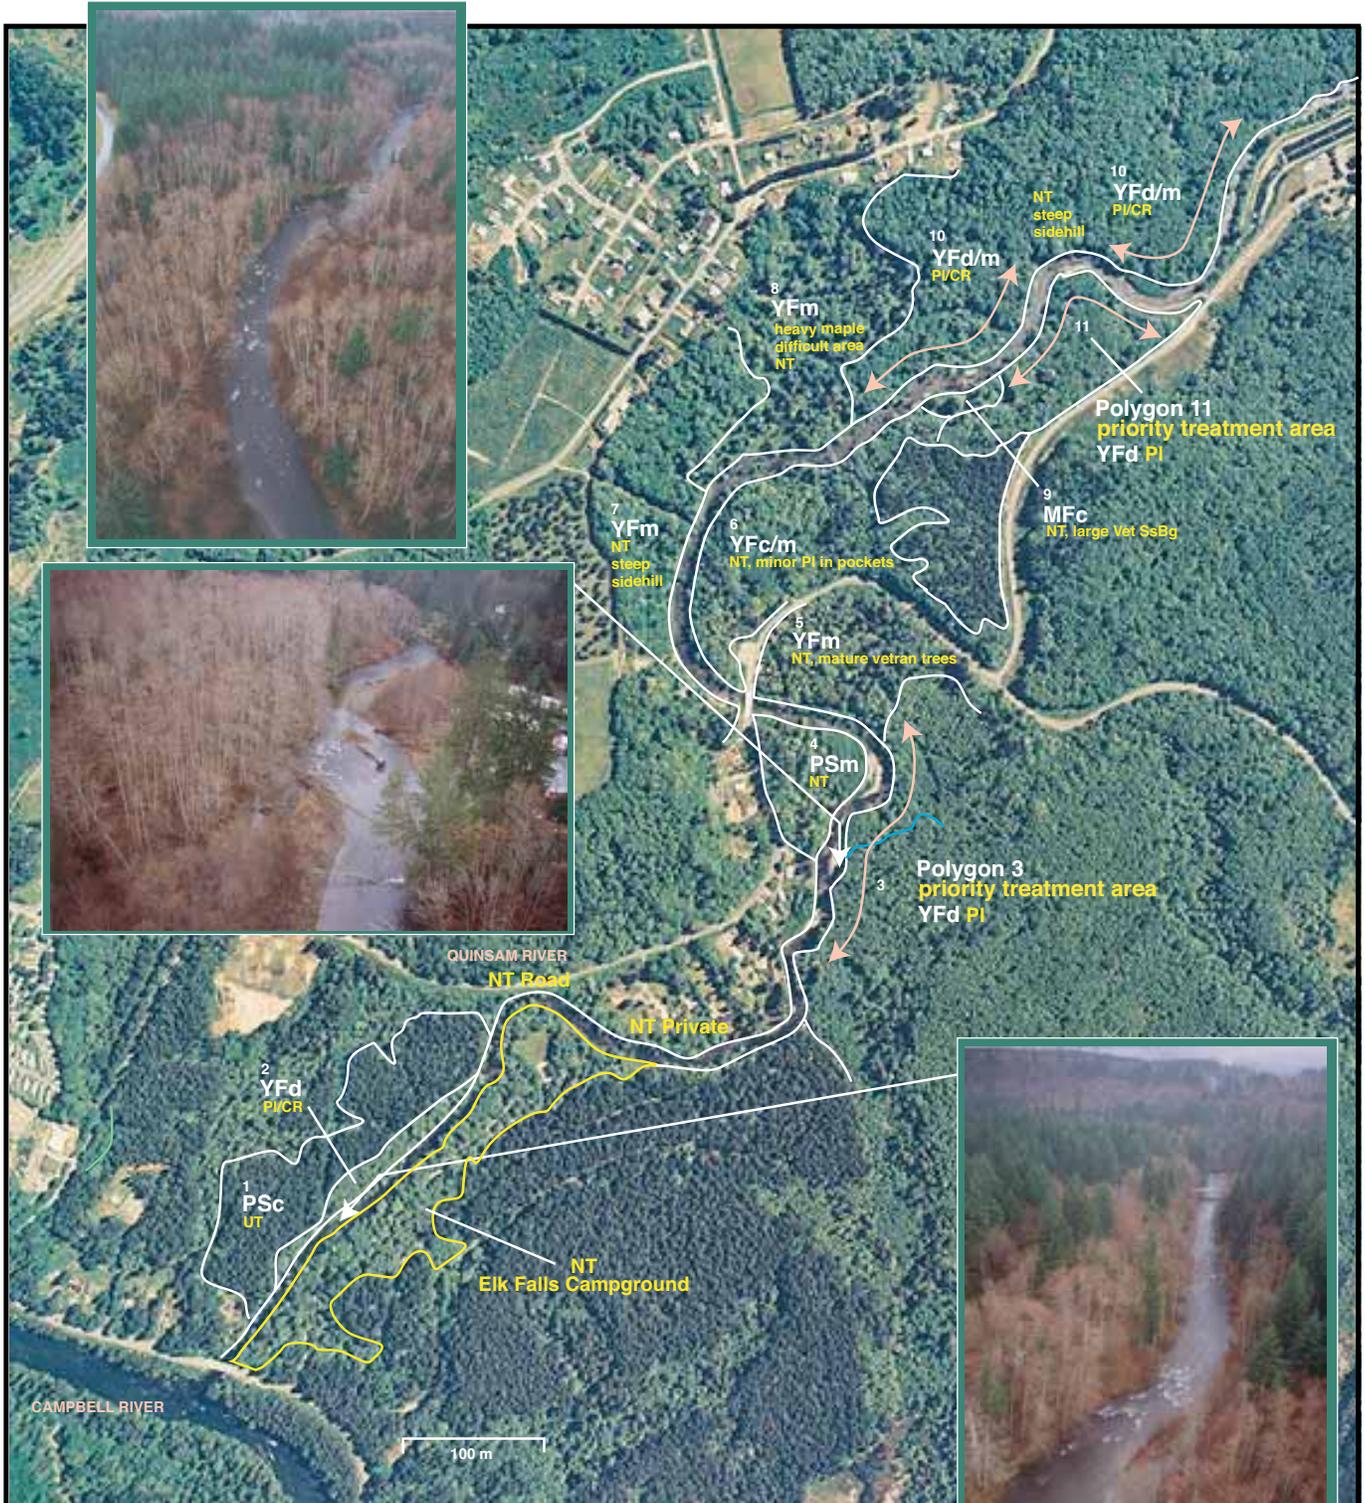
**Aerial Photo Mosaic Q1
 Quinsam River
 Location of Polygons**

V.A. Poulin/Dec/2004
 Area Locator:
 Photo: SRS 6062-206
 S1 riparian classification
 ⊕ survey plot
 0 100
 fix scale (original 10 000)

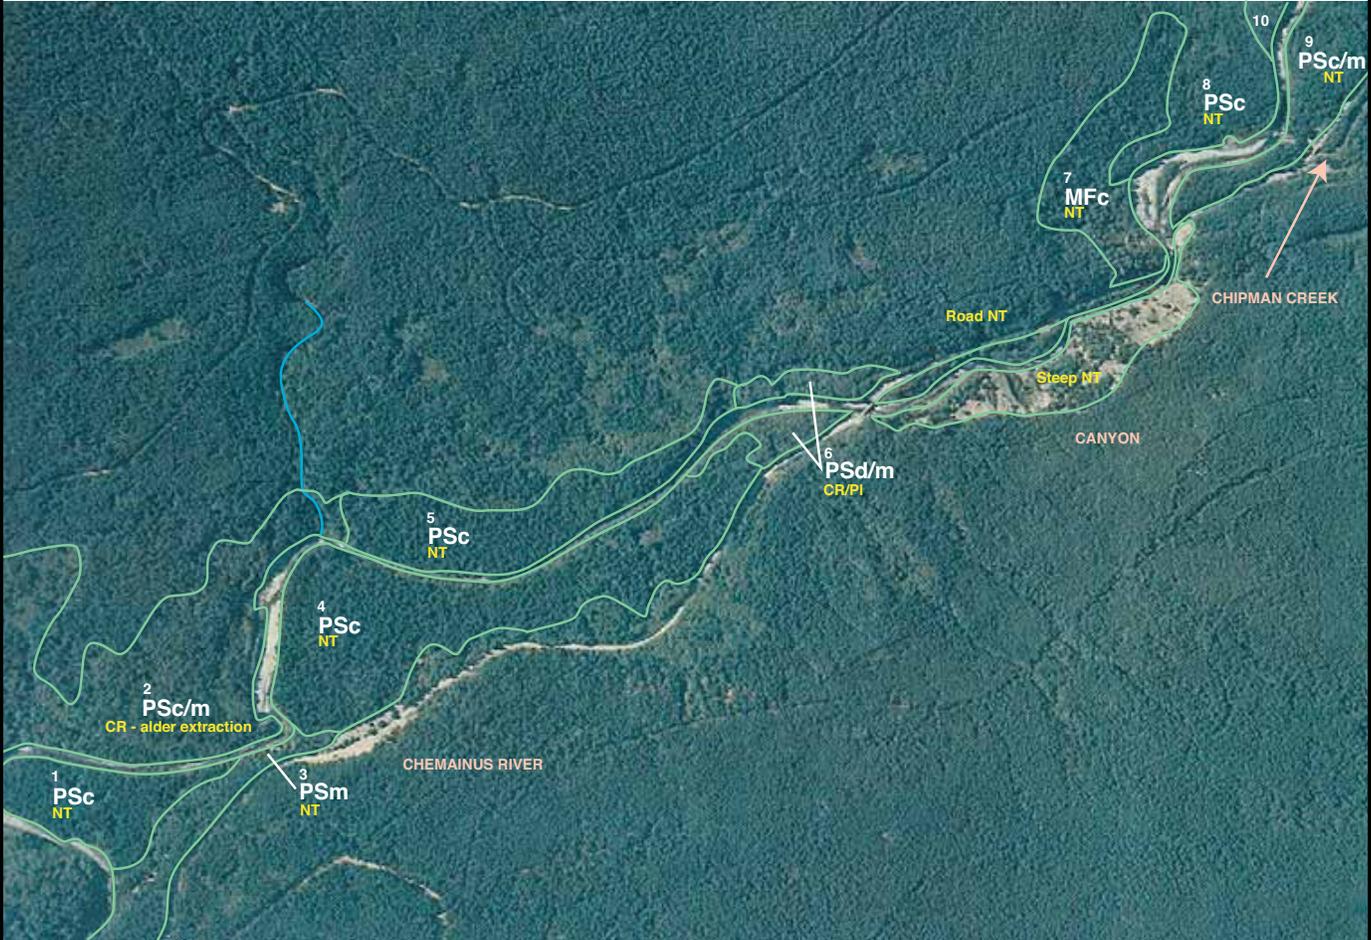
**Aerial Photo Mosaic C1
 Chemainus River
 Location of Polygons**

V.A. Poulin/Dec/2004
 Area Locator:
 Photos: 30BCC98055 168
S1 riparian classification
 scale: 1: 15000

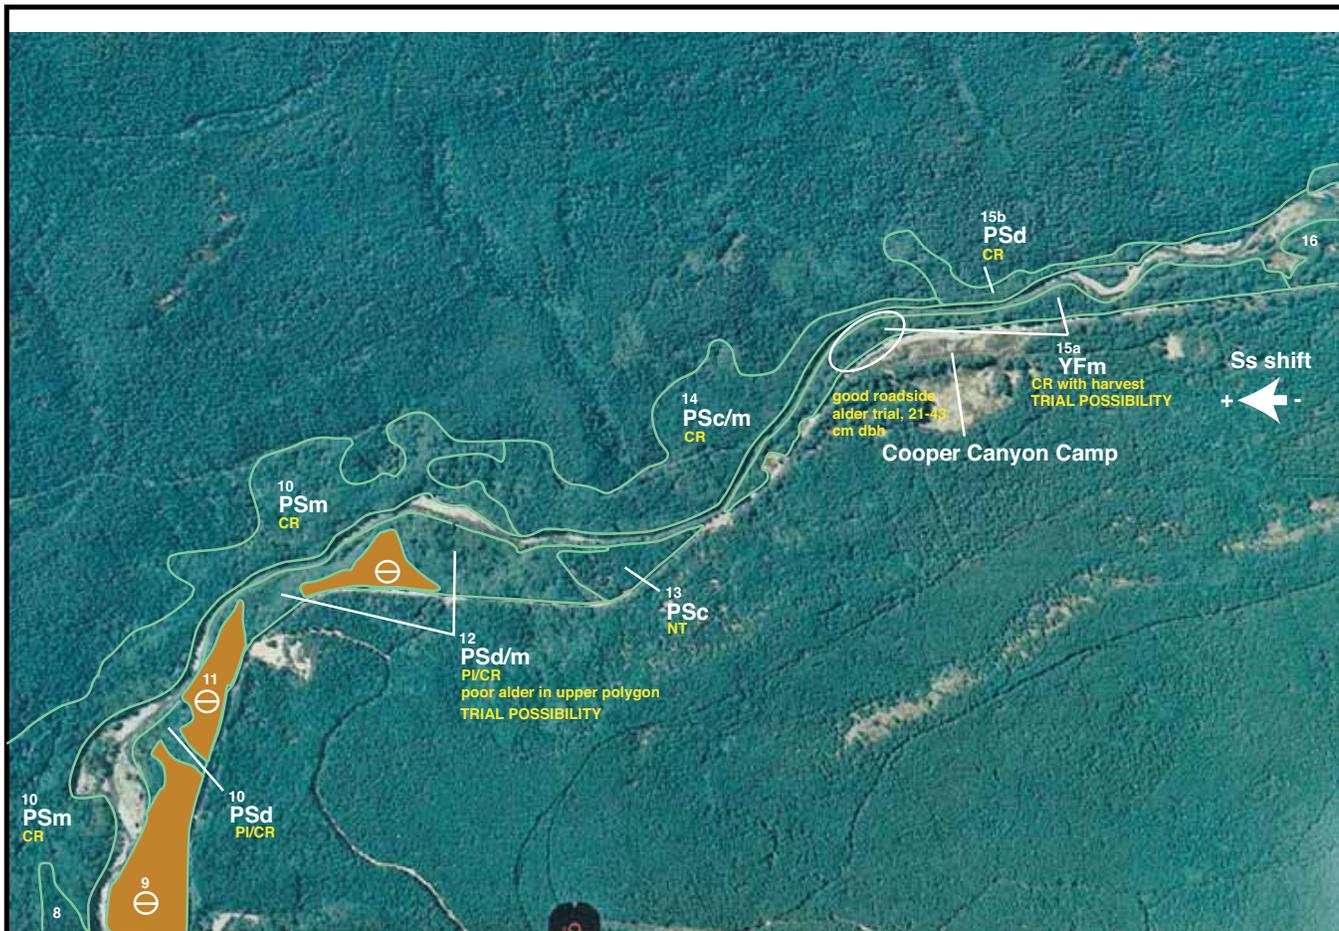
**Aerial Photo Mosaic C2
 Chemainus River
 Location of Polygons**

V.A. Poulin/Dec/2004
 Area Locator:
 Photos: 30BCC98034 119
S1 riparian classification
 scale: 1: 15000

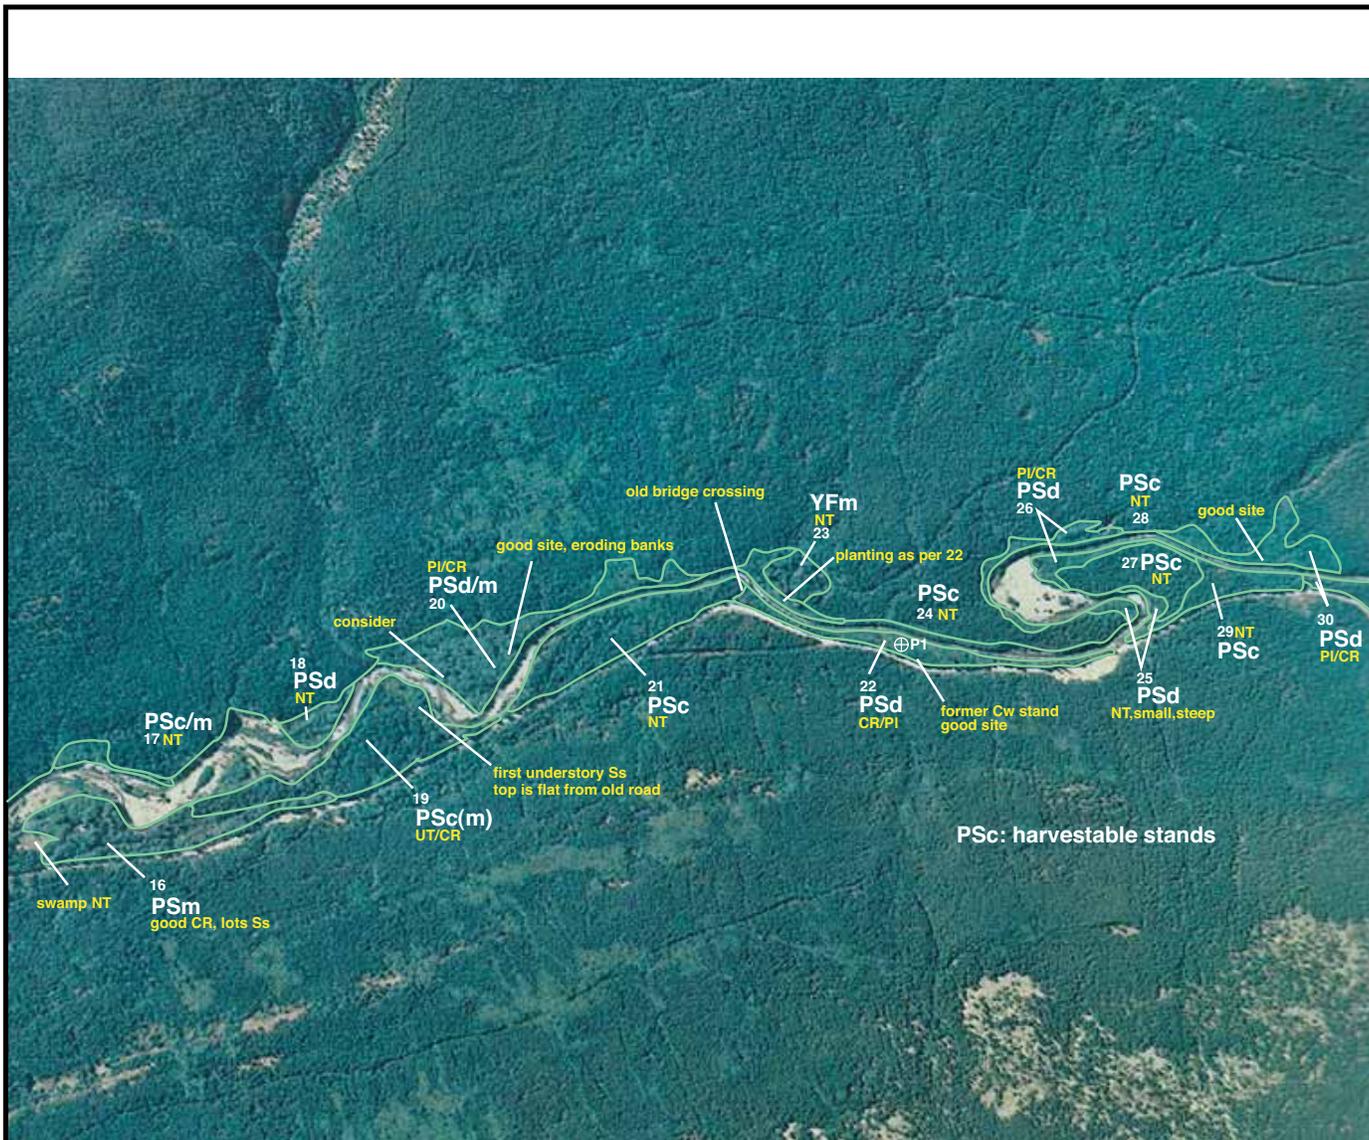
**Aerial Photo Mosaic C3
 Chemainus River
 Location of Polygons**

V.A. Poulin/Dec/2004
 Area Locator:
 Photos: 30BCC98034 117
S1 riparian classification
 scale: 1: 15000

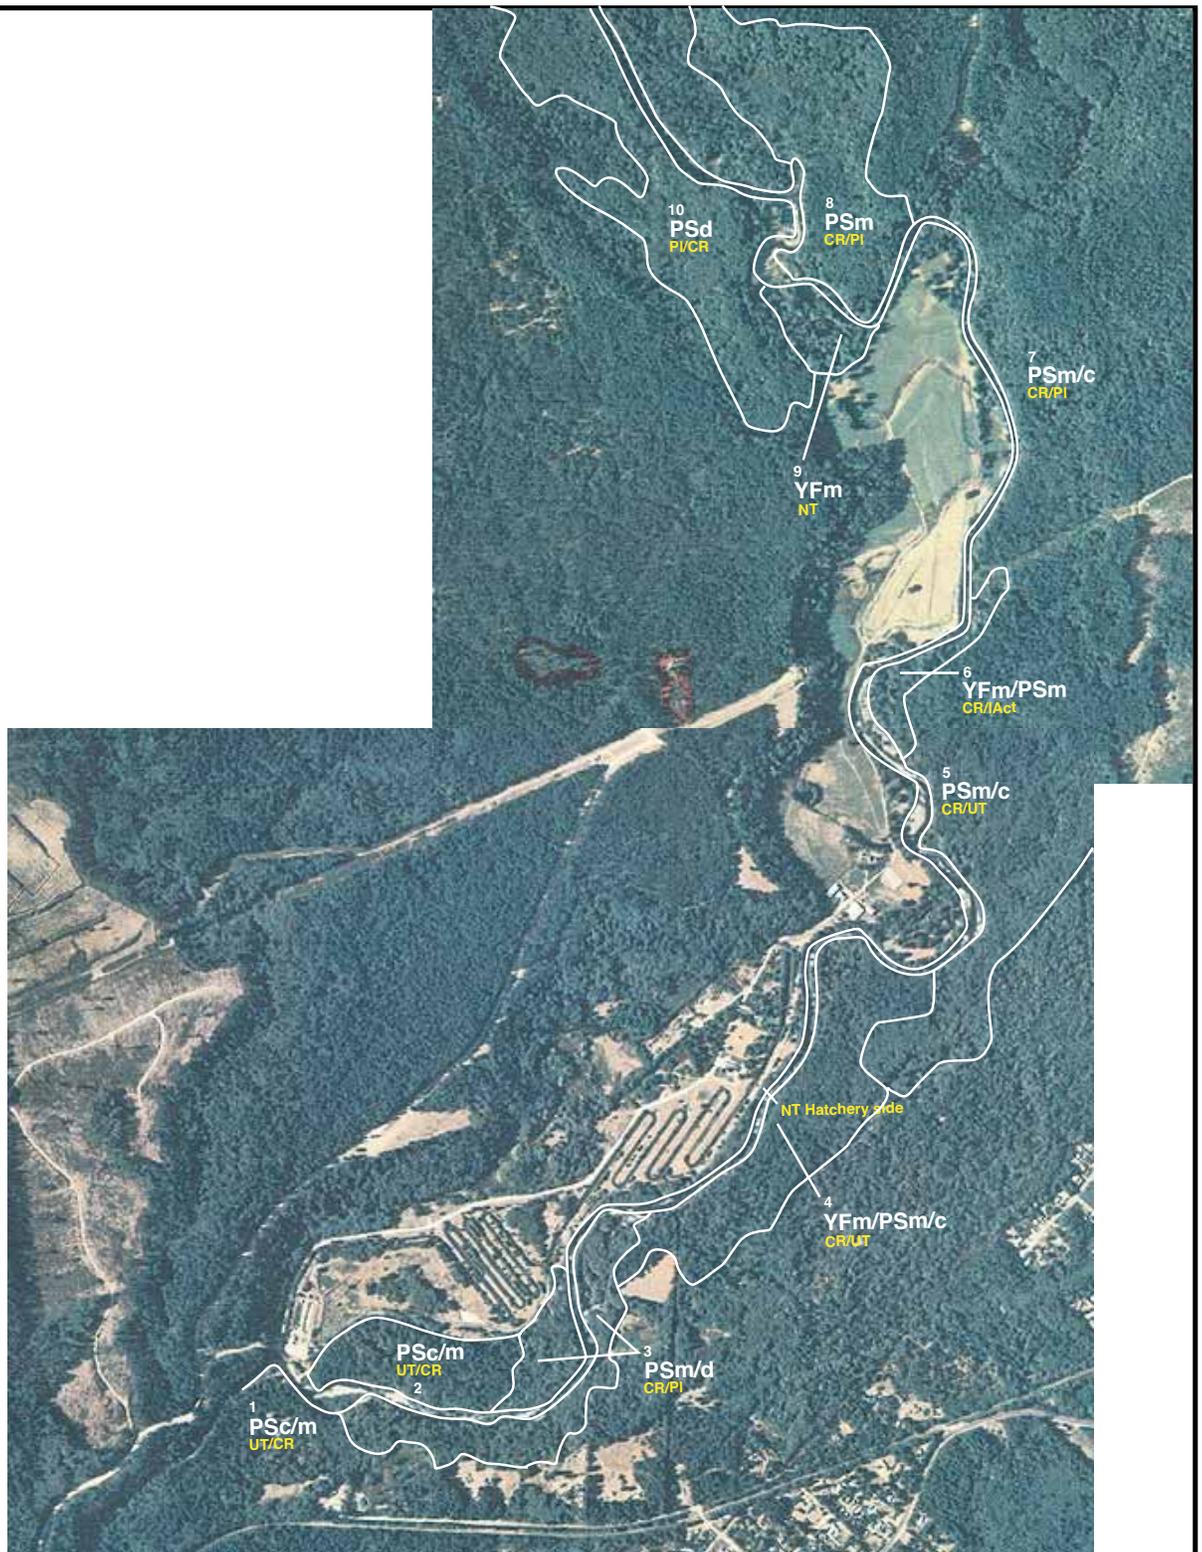
**Aerial Photo Mosaic LC1
 Little Qualicum River
 Location of Polygons**

V.A. Poulin/Dec/2004
 Area Locator:
 Photos: 30BCC98037 124
 30BCC98037 058
S1 riparian classification
 scale: 1: 15000
