# **Stream Flow, Water Quality, and Low-level Nutrient Monitoring in the Englishman River Watershed, 2002**

## **Englishman River Watershed Recovery Plan**

**April 2003**

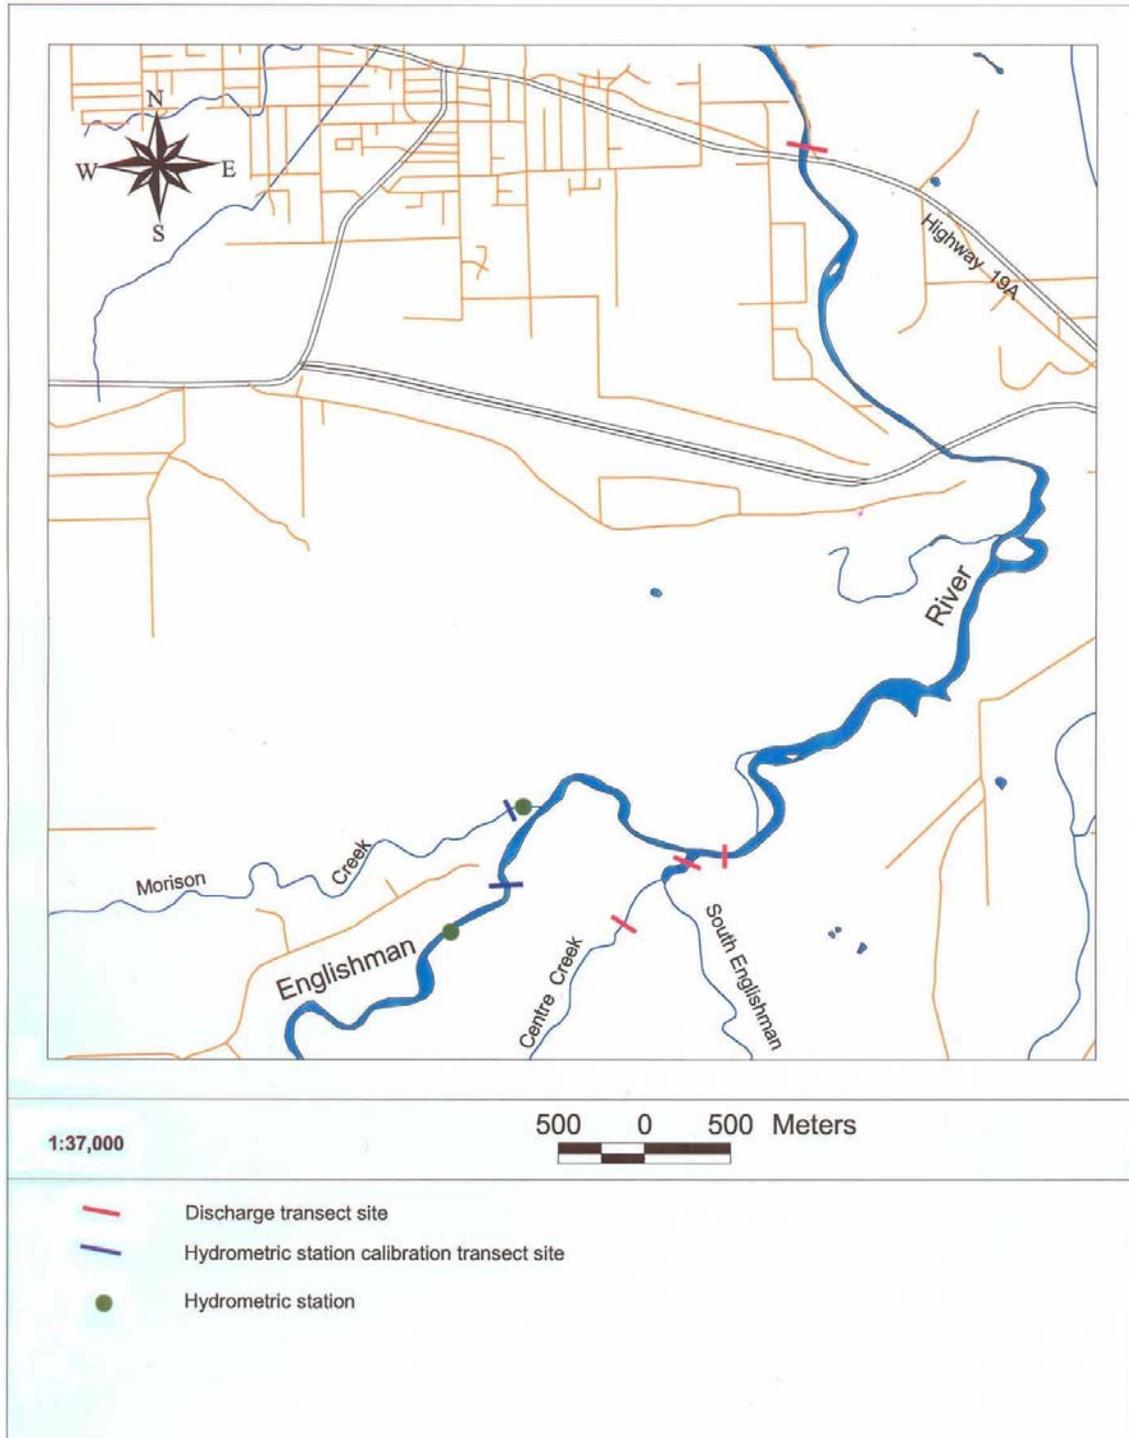
**Figure 2. Discharge transect and semi-permanent flow monitoring station locations.**

Discharge was measured in the Englishman River mainstem, South Englishman, Morison Creek and Centre Creek using Swiffer current velocity meters (Figure 2). Site selection and discharge measuring methodology was consistent with Resources Information Committee standards (RIC). Depth and velocity measurements were taken at a minimum of 20 stations equally spaced across the wetted width. The number of stations was slightly reduced in the smaller tributaries during low flow periods.

For continuous monitoring, semi-permanent pressure/transducer instruments were installed on Morison Creek and the mainstem by Edutech Technologies Corp. (Gibsons, B.C.). The pressure/transducers recorded hourly stage measurements. Discharge was manually measured bi-weekly, adjacent to the stream stage recorders to develop rating curves for the water level data (Appendix A). Staff gauges with references to benchmarks were set at both locations to allow for correction and confirm the pressure/transducers did not shift (Ferguson pers. comm.).

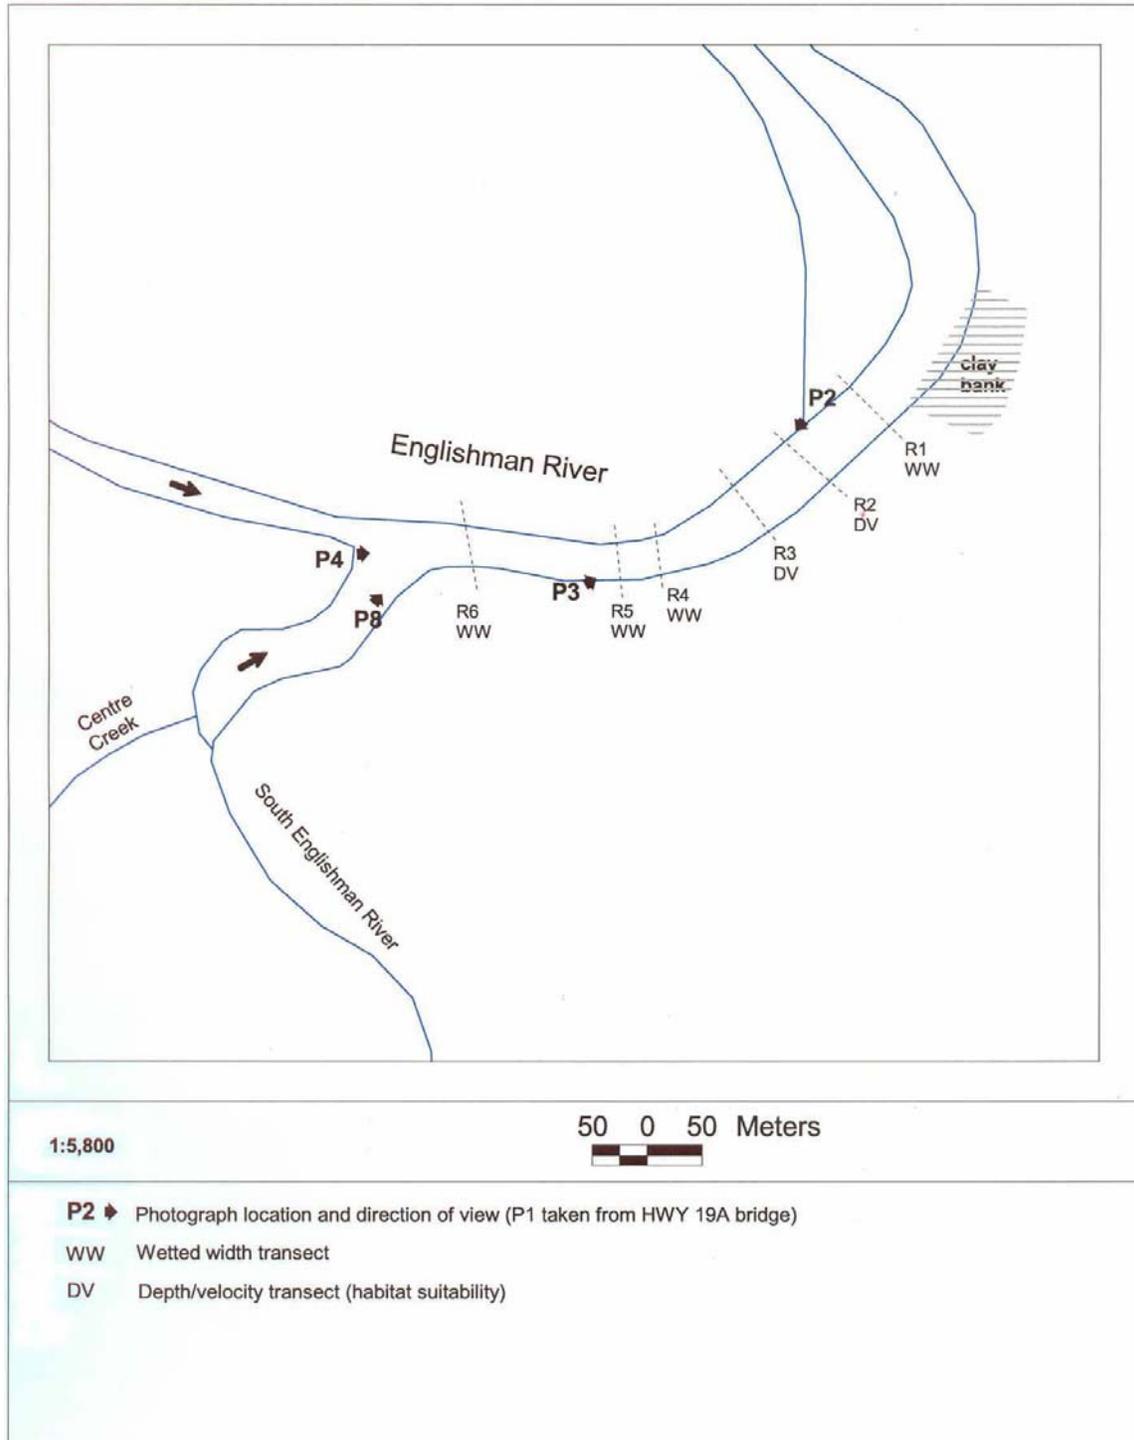
**Figure 3. Transect and photograph locations – downstream of South Englishman confluence.**

In addition to the depth/velocity transects, wetted widths were measured at eight different sites to monitor loss of habitat area (Figures 3 and 4). All transect locations were marked with rebar stakes and representative coloured flagging.

Photos were taken at seven marked locations on the mainstem to provide visual evidence of habitat loss as flows decreased (Figures 3 and 4).

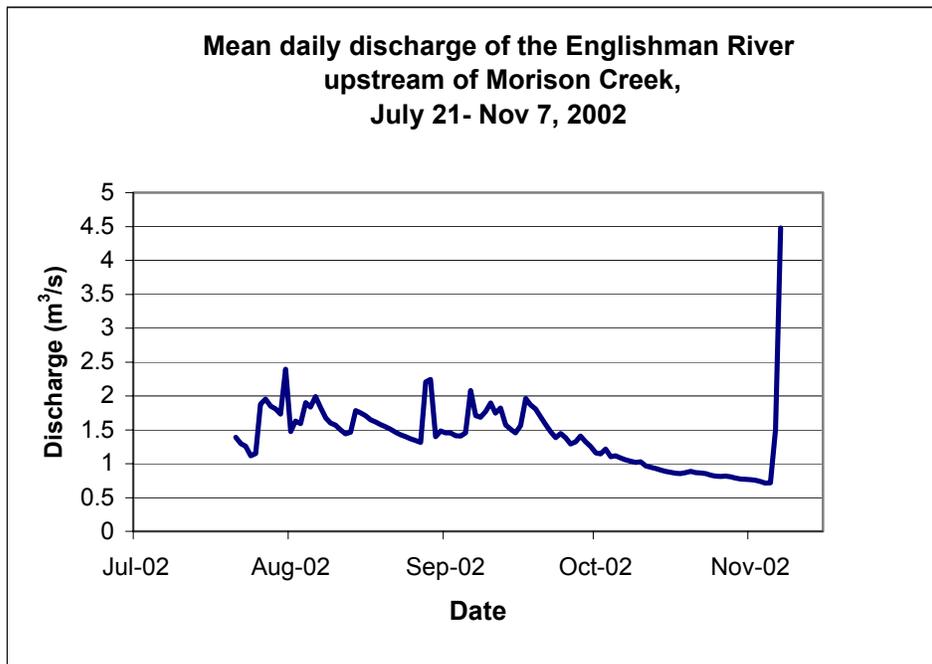
Discharge in the mainstem decreased rapidly from June 19 to July 24 (Table 1). Following July 24, the control structure at Arrowsmith Dam maintained a discharge of approximately 1.6 m<sup>3</sup>/s above Morison Creek until late September (Figure 5). By October, there was insufficient storage and flows dropped below 1.6 m<sup>3</sup>/s. The lowest measurement at the Highway 19A bridge crossing was 0.934 m<sup>3</sup>/s on October 18. Due to an unusually dry fall, flow continued to drop until November 6, when rains increased river levels considerably.

**Figure 5. Englishman River hydrometric station data upstream of Morison Creek, July 21 - November 7, 2002. (Note: Stage-discharge relationship does not account for flows greater than 4.4 m<sup>3</sup>/s)**

Due to an unseasonably dry summer and fall, discharge could not be maintained at 1.6 m<sup>3</sup>/s in the mainstem Englishman River between September 20 and November 6. Under normal conditions and perhaps with retained storage in the spring (i.e., June), discharge would have been maintained within the constraints of the current Provisional Operation Rule.

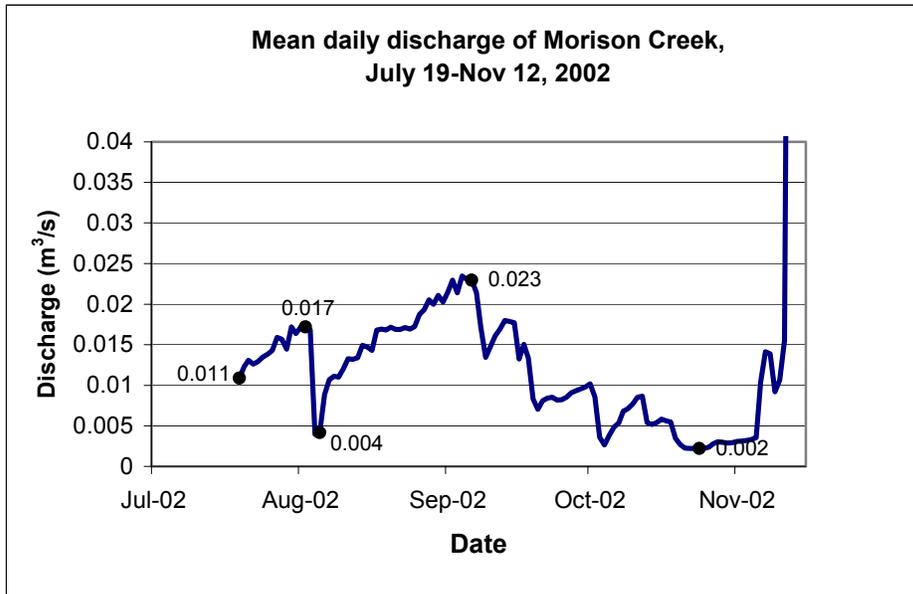
Mean daily discharge interpreted from the semi-permanent stream stage recording apparatus on Morison Creek is displayed in Figure 6. Following installation on July 19, discharge increased slightly from 0.011 to 0.017 m<sup>3</sup>/s, then dropped sharply to 0.004 m<sup>3</sup>/s on August 4 and 5. Discharge increased through August and then dropped slowly from 0.023 m<sup>3</sup>/s in the first week of September to 0.002 m<sup>3</sup>/s on October 21. As with the mainstem, flows increased dramatically on November 6.

**Figure 6. Morison Creek hydrometric station data, July 19 - November 12, 2002.**

Rural or agricultural water use may have caused discharge in Morison Creek to drop to 0.004 m<sup>3</sup>/s on August 4. It is unlikely the low reading was a result of a stage recording error because there are several points that support the trend. Water use in the headwaters should be examined further to identify the cause.

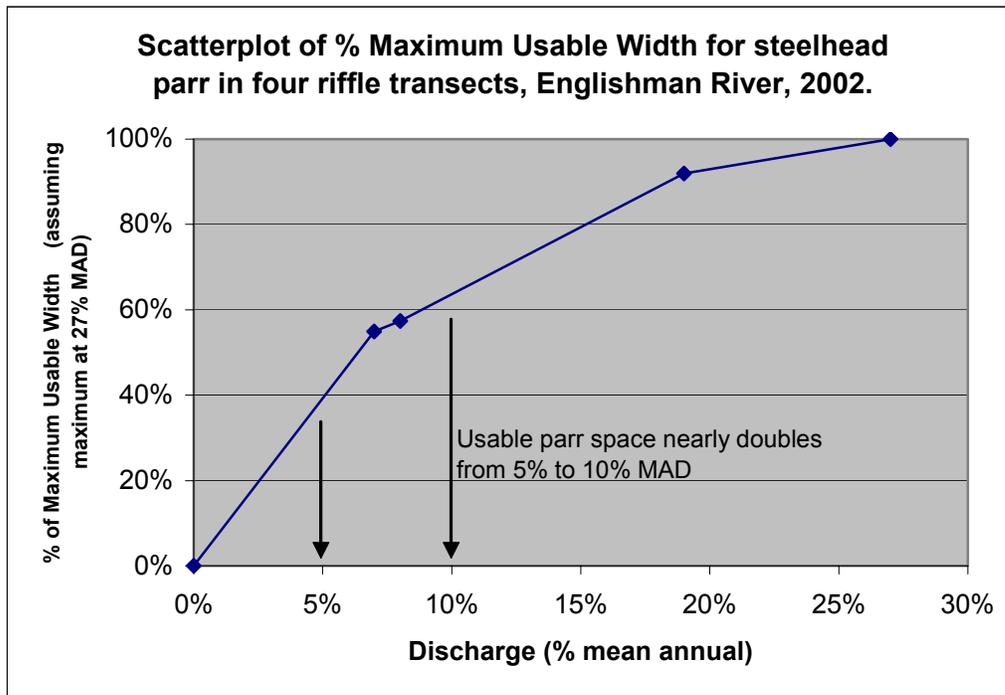
A further analysis showed that roughly 90% of the maximum rearing space for steelhead parr is maintained at 19% of MAD (Figure 7). Significant habitat losses occur below 10% of MAD. This analysis was based on the assumption that maximum rearing space was obtained when flows are at 27% of MAD, so consequently 19% of MAD still provided relatively significant habitat area.

**Figure 7. Scatterplot of % maximum usable width for steelhead parr in four riffles sampled in the Englishman River mainstem, June - October, 2002 (analysis provided by Ron Ptolemy).**

MWLAP staff have identified that rearing flows near 20% of MAD would be ideal, but that 10% is an acceptable short-term minimum base flow (R. Ptolemy pers. comm.). Results from habitat suitability, wetted width, and visual observations confirm habitat loss is not significant until flows drop below 19% of MAD (Figures 7, 8, and 9).

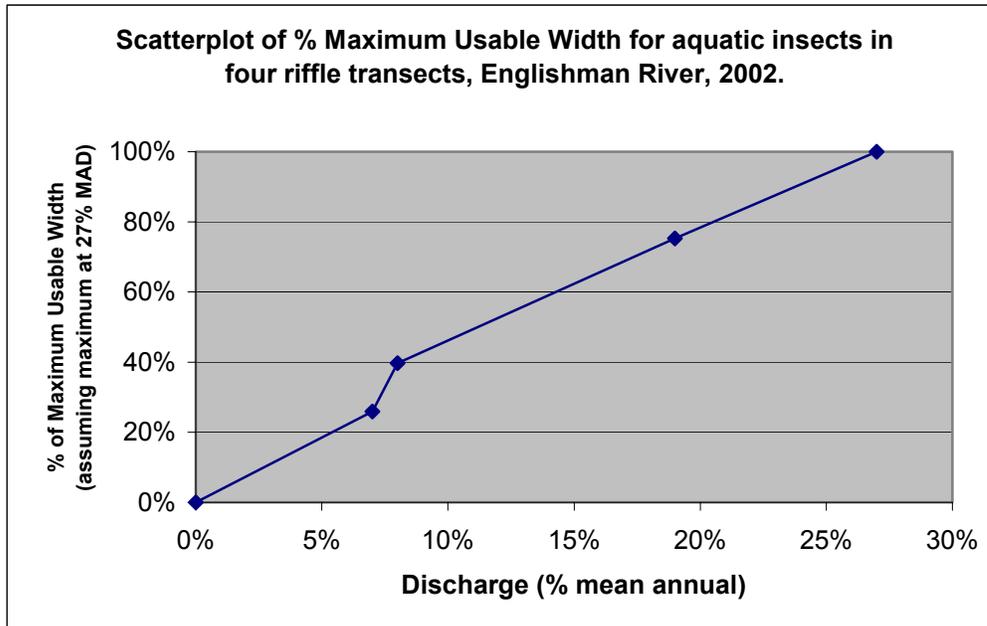
The percent of maximum usable width for aquatic insect production decreases linearly as flows drop from 27 to 8% of MAD (Figure 8). At 19% MAD, 75% of the maximum rearing space is maintained. Below 8%, there is a very sharp reduction in usable width.

**Figure 8. Scatterplot of % maximum usable width for aquatic insects in four riffles in the Englishman River mainstem, June - October, 2002 (using suitability curves from Stalnaker and Arnette 1976).**

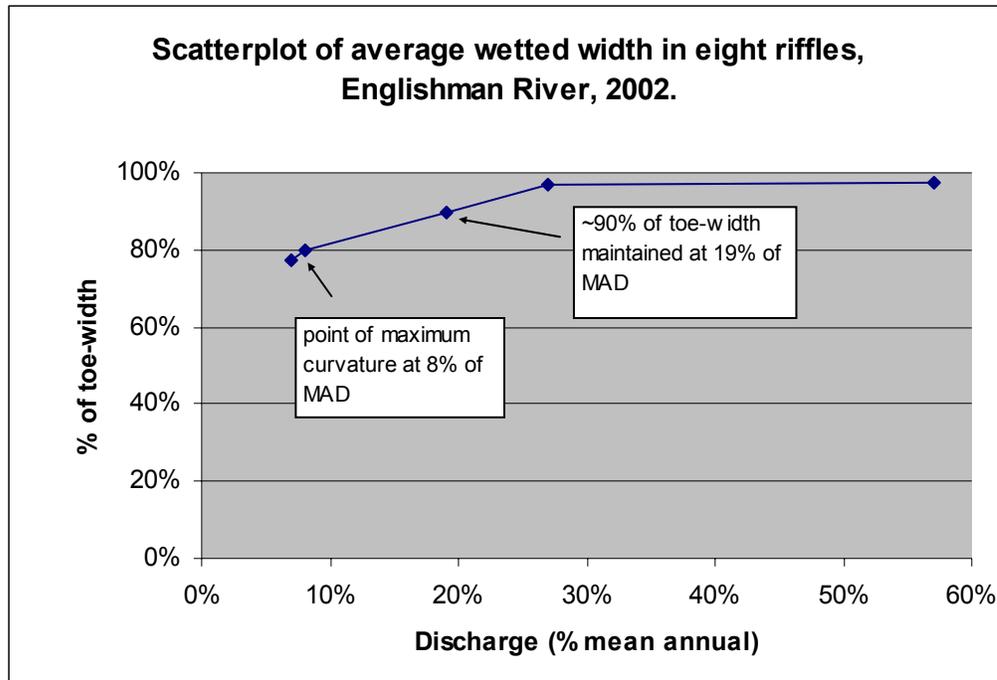
Wetted width measured in eight other riffles sites confirmed a gradual loss of habitat area as discharge dropped below 27% of MAD (Appendix C). The percent of wetted width maintained relative to toe-width<sup>5</sup> is expressed in Figure 9. This analysis shows that approximately 90% of toe-width was maintained at 19% of MAD, and approximately 80% of toe-width was still maintained at 8% of MAD. The single data point at 7% of MAD indicates that more rapid loss of wetted area likely occurs at lower flows.

**Figure 9. Scatterplot of % toe-width at eight riffle sites on the Englishman River, June 18 - October 18, 2002 (analysis provided by Ron Ptolemy).**

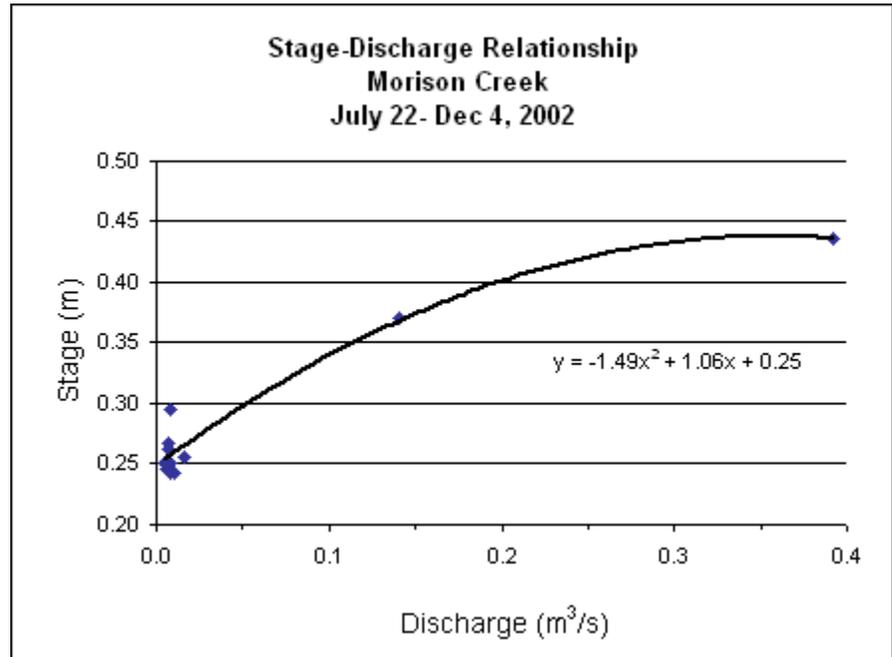
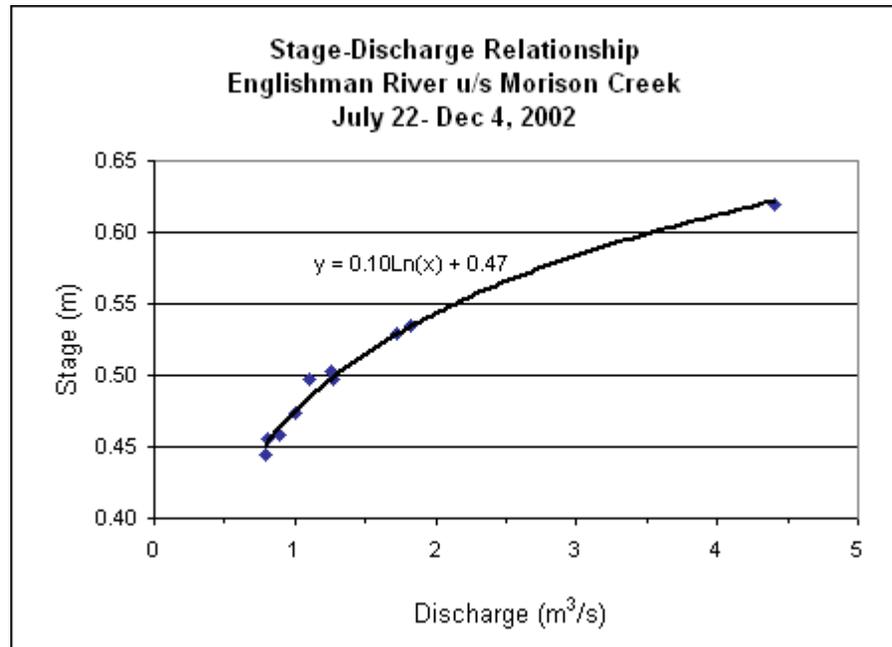
**Stage/discharge relationships for Englishman River and Morison Creek  
semi-permanent stage monitoring stations.**

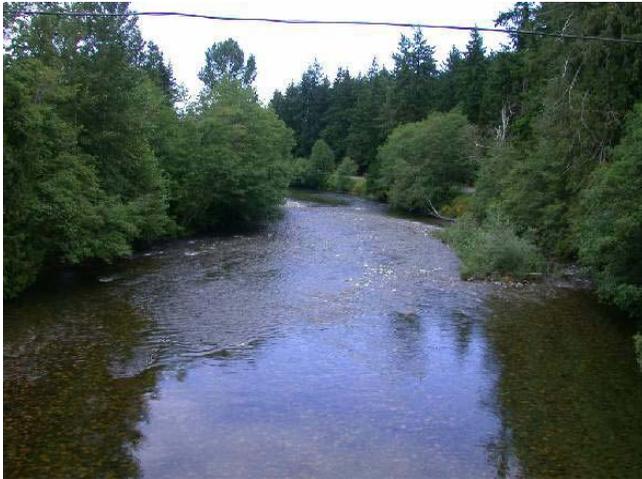
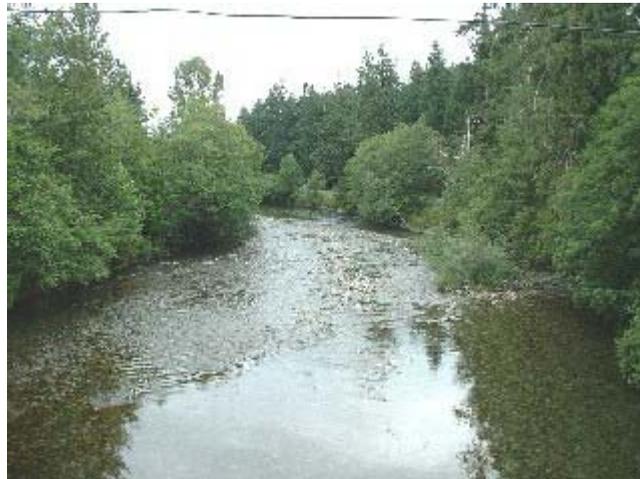
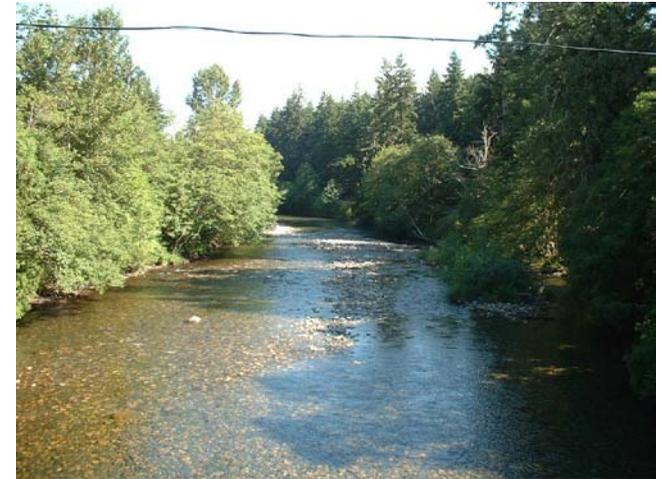
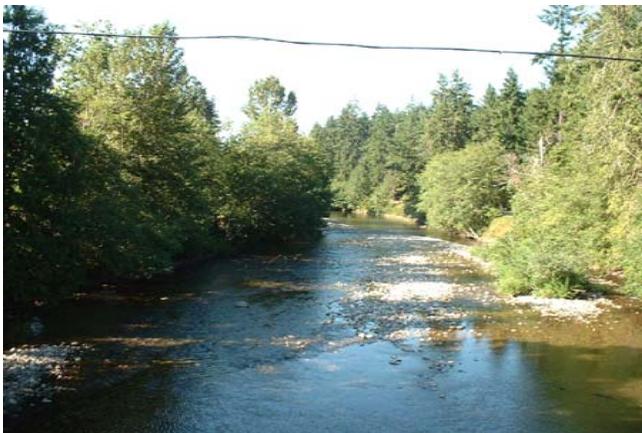
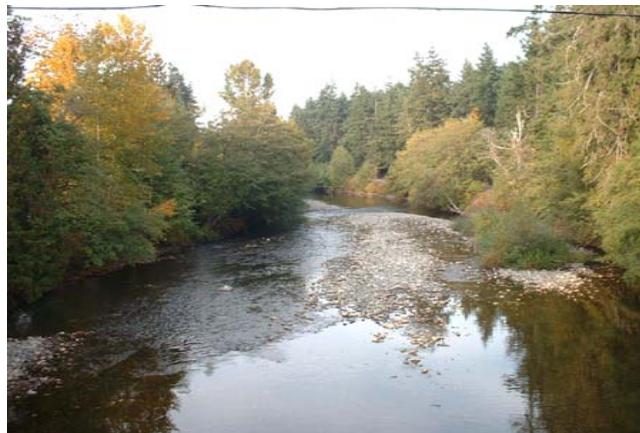
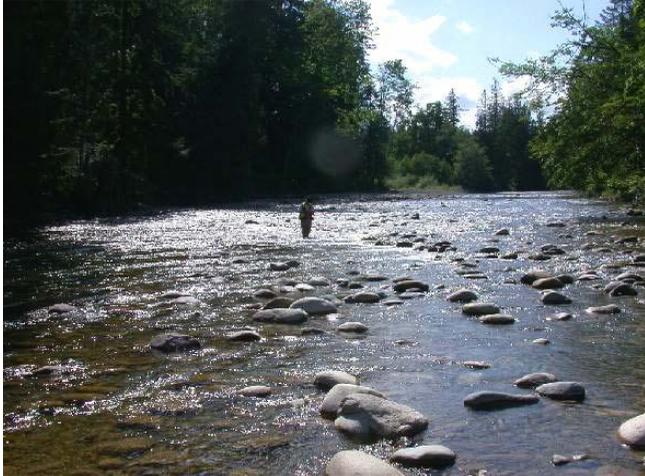
Photographs of representative habitat also reflected the loss of habitat area and hydraulic suitability (Appendix D). Visual evidence of habitat loss was most apparent between 19 and 8% of MAD.

**Habitat photographs at 57%, 27%, 19%,  
8%, and 7% of mean annual discharge.**
