Englishman River Habitat Status Report

Mid Vancouver Island Habitat Enhancement Society

October 31 2013

David Clough, RPBio
D. R. Clough Consulting
Fisheries Resource Consultants
6966 Leland Road Lantzville B.C. V0R 2H0
Ph/fax: 1-250-390-2901, email: drclough@shaw.ca

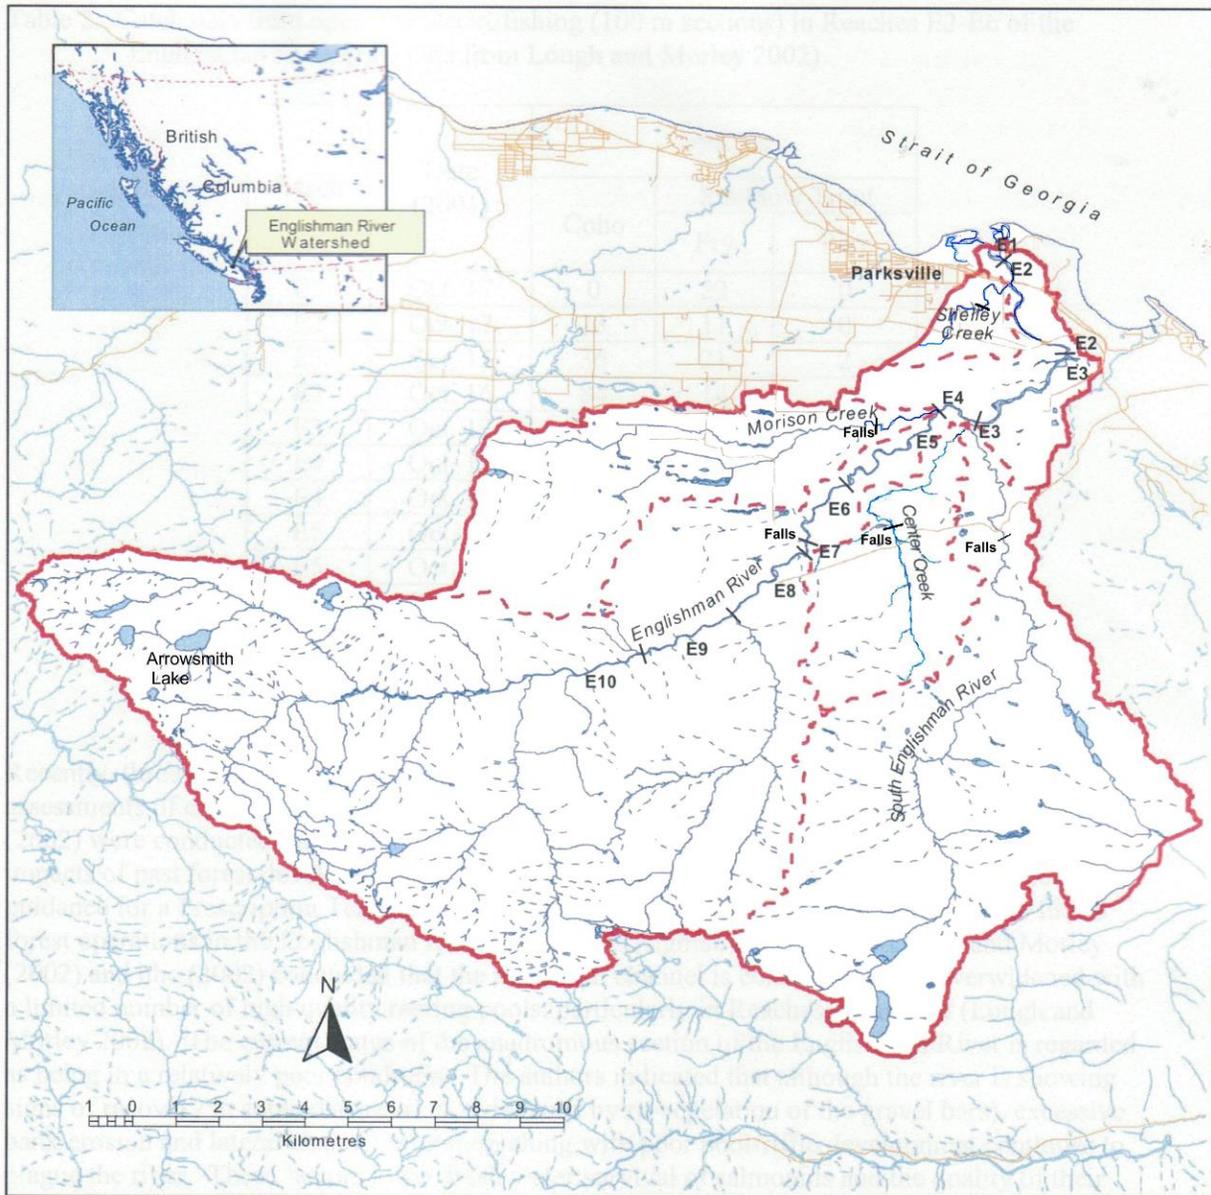
Figure 1: Englishman River Watershed with Reach Breaks.³

The Englishman River reach segments were prescribed by Rood (2002) using gradient, sinuosity and confinement as the primary determinants. The river was found to have six anadromous segments to the falls (15.2 km). Above the falls, assessments ended at the top end of reach E10 next to Moriarty Creek confluence; at 24,720 m and 288 m elevation from the estuary. The river mainstem continues upstream approximately 10,500 m to Arrowsmith Lake (812 m elevation). Lough and Morley (2002) used these reach segments in their description of fish habitat. These baseline studies were somewhat limited in scope due to the short delivery timelines; thus not the entire watershed was assessed. The entire mainstem length is approximately 35.2 km. The authors recommended the other areas be analyzed. The Estuary is part of reach E1 but was segregated for this report due to additional references.

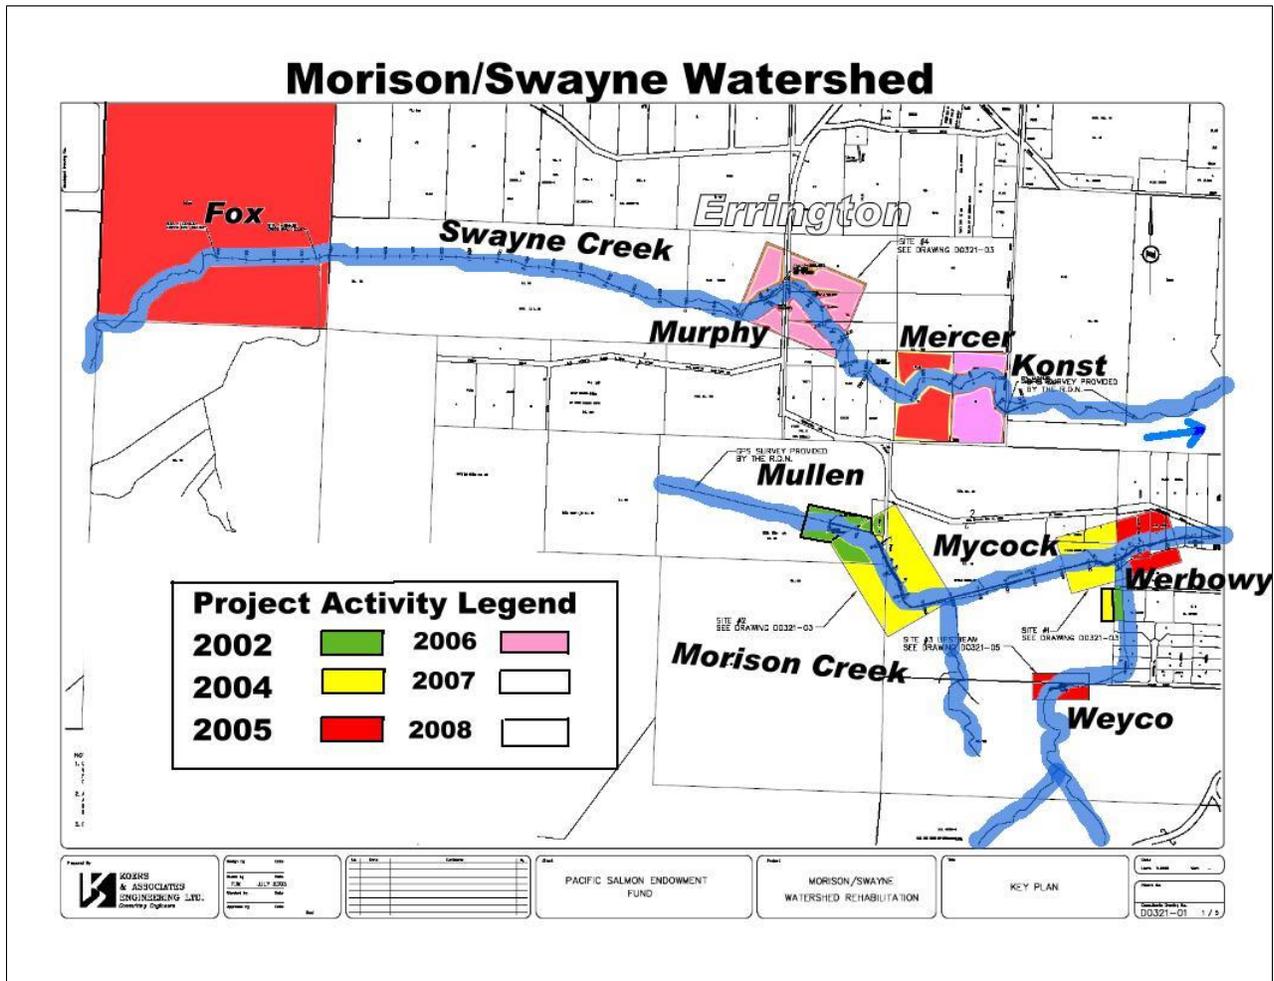
Figure 4: Morison/Swayne Watershed Rehabilitation Area Map, 2005.

As part of the ER Watershed Recovery Plan, farm stewardship was initiated by farmer Paul Mullen and the Morison/Swayne Landowners Committee was formed which included properties situated along the headwater M4 and M5 reach as well as Swayne Creek. This work involved eight large farm properties as well as private forest lands (Weyco) and was supported by PSEF, PSF, DFO, MVIHES and the property owners. Planning and restoration work was done from 2000 to 2007 (MVIHES 2005). It included a channel profile survey by Koers and Associates Engineering (2005) of the farm reaches to determine restoration areas where pastures were flooding from sedimentation, bank erosion from livestock and riparian improvement. This work reduced the sediment sources from farms identified as high priority in the Lough & Morley report.

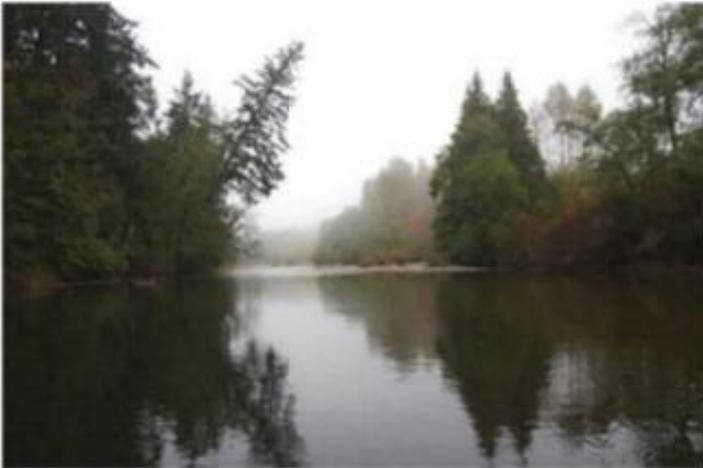
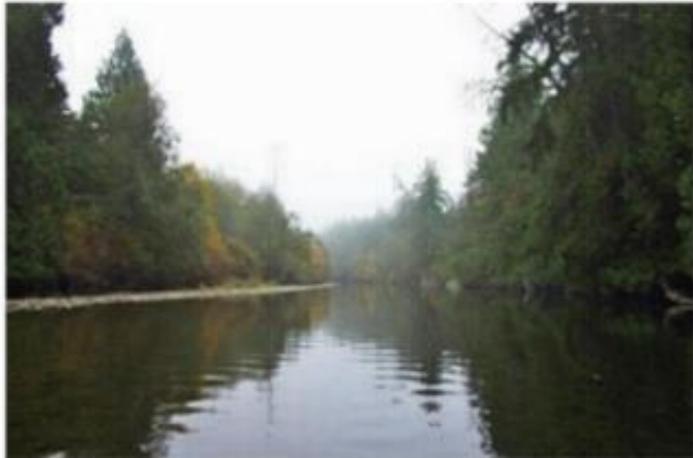
Englishman Reach E2 and E3 Photographs

Morley and Lough (2002) noted the dominant substrate is cobble with subdominant pockets of gravel. They observed few pools other than the deep bedrock canyon pool at the top of the reach. Cover and refuge habitat was found to be lacking as well.

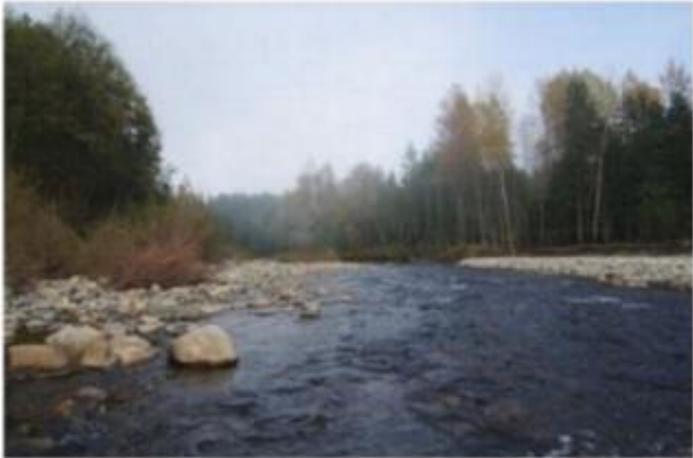
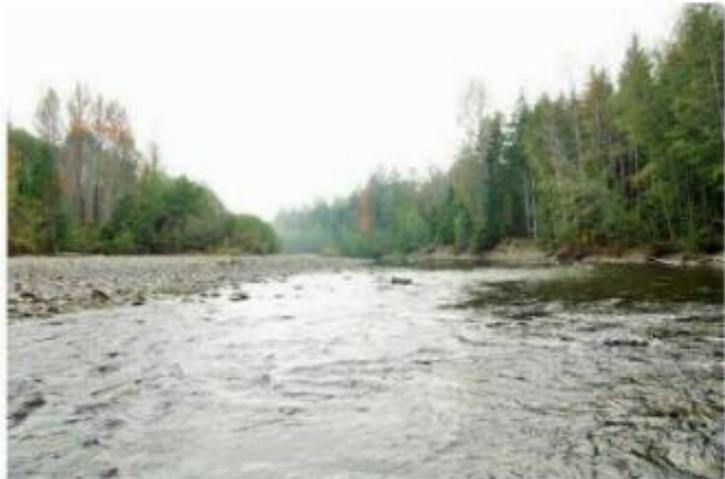
Reach E3 DS

Reach 3, along with Reach 2, constitutes the majority of holding water for salmonids in the Englishman River (Gaboury 2005). Beginning at 4.7 km upstream, it is a long (3,490 m) low gradient (0.6%) reach from Top Bridge to the South Englishman confluence. It is lacking in almost all habitat requirements for salmonids other than spawning gravel. Morley and Lough (2002) cited low summer flows, poor adult holding, inadequate pool frequency and lack of cover (LWD, boulders) as well as poor winter refuge.

The riparian forest surrounding the river in this reach, is of an insufficient size to assist in bank stability. The trees, after falling in, are quickly moved downstream into non-functional locations (McCulloch, 2005). The limitations in cover habitat were well identified by Morley & Lough (2002) and Rood (2002) in their overview reports. They recommended LWD placement and cabling standing trees.

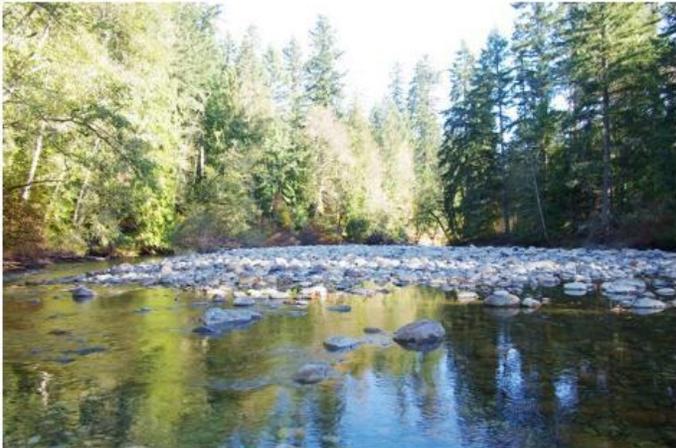
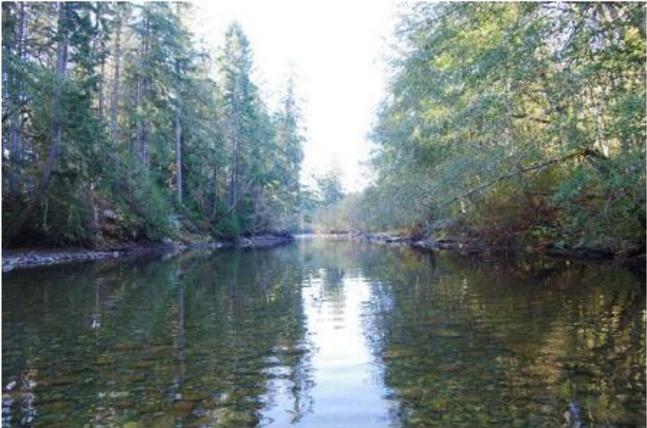
Reach E4 DS

A steeper gradient (0.7%) reach that flows from Morison Creek down to the South Fork at 8.2 km from the ocean. Its most recent channel width is 37 m (Gaboury 2005). It meanders to the left bank past the sidechannel intake and then over a wide bar to right bank before ending at the South Fork. Morley and Lough (2002) noted the long shallow riffles and lack of pool habitat. It is sensitive to low flow and limiting in refuge and cover habitat. Rood (2002) found erosion of a mainstem island over the last 20 years was a significant example of lateral instability of the channel. This reach is adjacent to the hatchery building on the left bank. It is at the top end of road access through the Englishman River Regional Park from Allsbrook Road. There is a TimberWest logging road parallel to the river on the right bank.

Habitat is poor in this reach with the exception of Morison pool. It has low summer flow, erosion, lack of pools, sparse LWD and no refuge habitat, all identified by Morley and Lough/Rood, 2002. Gaboury (2005) noted the average channel width has increased from 26 m to 37 m since 1949.

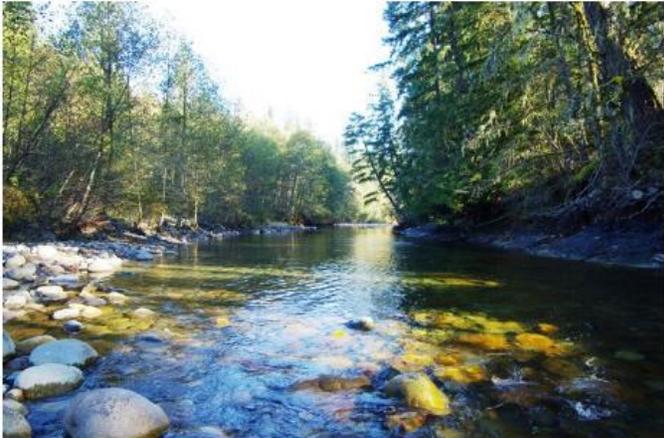
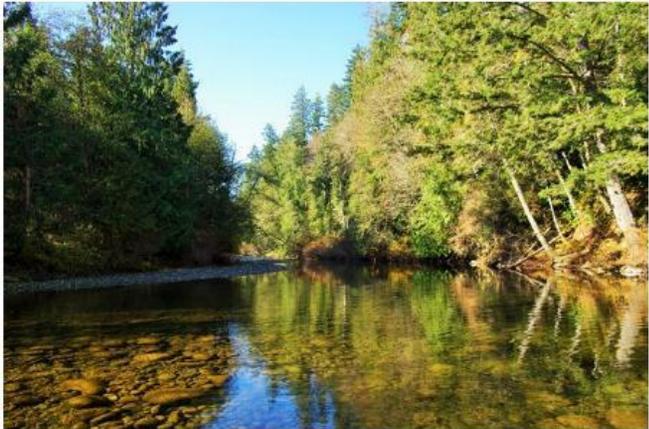
Reach E5 DS

This reach was noted by Rood (2002) as having an irregular meander with a nearly continuous floodplain. Starting at 9.4 km the river gradient is steadily rising with an average gradient of 0.8% for its 4,120 m length and 29 m average width. The reach ends at 13.5 km as the channel changes from frequently confined to confined – characterized by a change to a narrower valley and steeper bank slope. It flows adjacent to the Englishman River Road subdivision on the left bank and the TimberWest logging area on the right bank.

The meandering channel results in lateral and point bars, islands and mid channel bars (Rood 2002). The many gravel deposits offer considerable spawning habitat reflected by the high number of Pink salmon found in the reach compared to E4 (Gaboury 2005).

Lough and Morley (2002) noted sparse instream cover and pools which limit adult and juvenile fish holding. Rood (2002) noted that the streamside logging impacts and associated erosion prior to the 1950's created significant sediment accumulation but many bars are now growing vegetation.

No restoration is noted and access may be a challenge. This reach is in a semi confined valley with 30 m sidewalls on the residential (left) side but much lower on the TimberWest (right) side. Blackman & Hurst (1988) noted seven natural offchannel areas in this reach for potential development. Lough and Morley (2002) suggest restoration at two sidechannel locations.

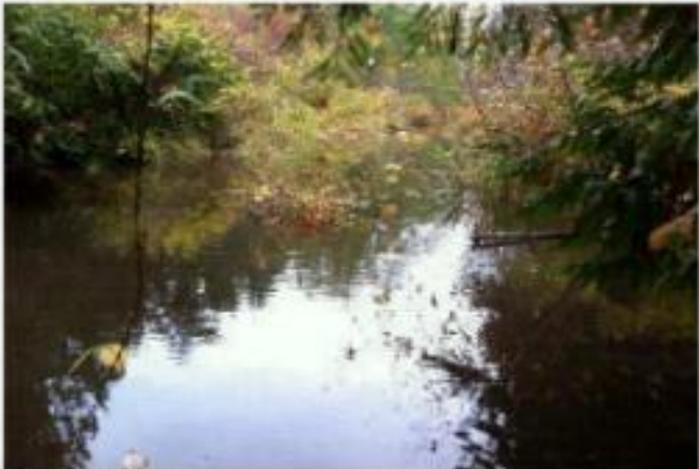
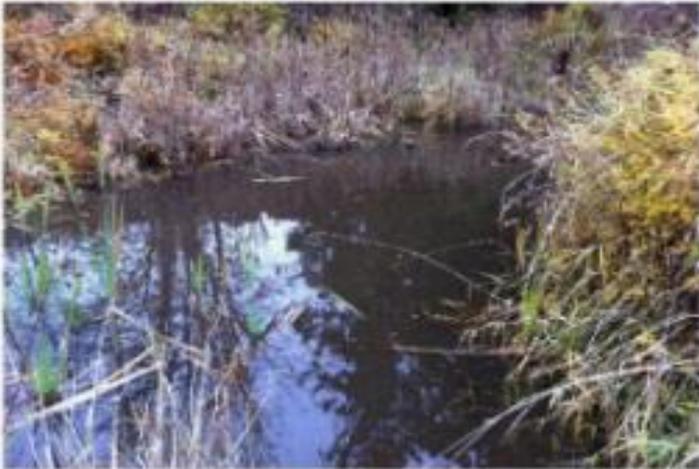
Shelly Creek R2

Shelly Creek is the lowest tributary on the Englishman River. It enters the mainstem Reach E2 on the river-left (Parksville) side just above Hwy 19a. Morley & Lough (2002) identified Reach S1 as approximately 200 m from the river through a wetland to Martindale Road. Reach S2 is approximately 830 m from Martindale upstream through wide deep pools created by low beaver dams to a 5 m barrier at an escarpment with a hanging culvert in the farm area. This is the end point of salmon access as the channel was ditched and diverted from its original course (Burns 1995). It has another approximately 4 km of mainstem habitat length above the culvert that flows through farm, residential and transportation corridors. An Urban Salmon Habitat Assessment was conducted on the stream from the Englishman River up to the railway crossing identifying 12 reach segments (Walshe 1999). The Shelly watershed has the highest proportion of private residential/rural ownership (84.5%) with timber companies owning 13% (Bocking & Gaboury 2005). This reach was mapped and inventoried by the MVIHES (2009).

This is the most farm and urban developed sub basin of the Englishman watershed. The mid reach area was historically ditched and relocated from its natural channel (Burns 1995), it appears to have had anadromous access in its historic state. Buechert (1999) noted farm areas of riparian impairment where the trees were removed. Parksville Streamkeepers (2002) identified a list of restoration opportunities from a literature review. Most restoration opportunities were from Walshe (1999) which described limiting factors such as; ditching, storm water, riparian, low flow, spawning gravel, water quality and fish barriers. In 2012 the MVIHES assessment found three problem culverts for fish migration; at Martindale Road (submerged), hanging culverts in Reach S2 (5.0 m ht.) and Blower Road crossing (1.2m). The reach S2 ponds have critically low oxygen in spring as the last Coho smolts leave⁶ which is likely due to the high nutrient loading (detritus) and lack of high riparian cover adjacent to the farm pasture. The high nutrients and sun exposure are also the reasons why the Coho smolts stay and rear in spring long after the floods are over in the mainstem.

There has been no documented restoration on this creek. The assessments (gps mapping, barrier locations and smolt trapping) from 2011 to 2013 by the MVIHES indicate it is important off channel habitat to the mainstem Englishman River that should continue to be protected. There are barrier culverts on the creek at almost every road crossing that, if repaired, could offer further improvements to migration for both salmon and resident trout.

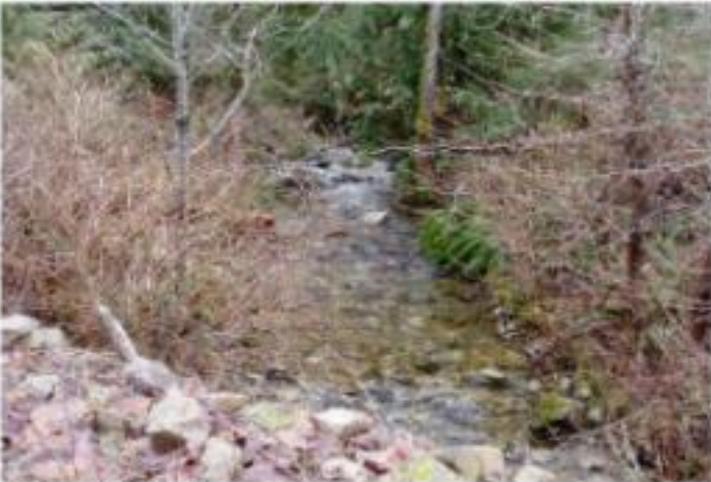
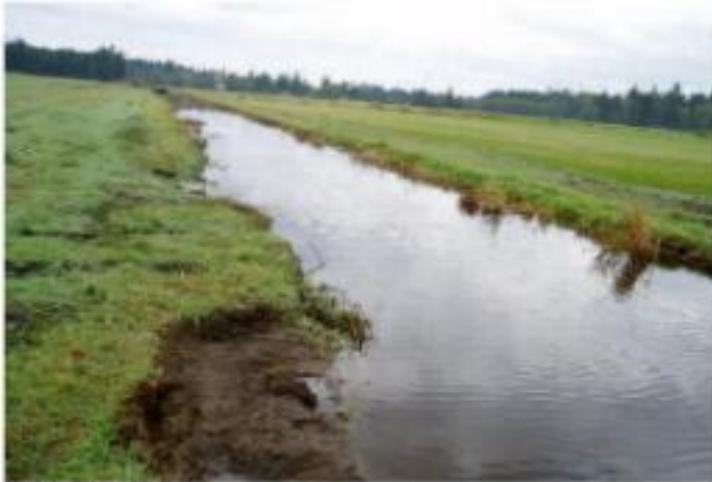
Morison Creek R1

The stream has two low gradient reaches of anadromous access of 2,050 m ending at "Triple Falls" (local name). An unpublished assessment noted the falls are one 8 foot and two 6 foot drops onto bedrock⁸. Reach M1 is a short (135 m) initial reach of boulder riffle (2%). Reach M2 is 1,855 m long on 0.7% gradient with more riffle (40%) glide (53%) than pool (7%) based on samples by Lough and Morley 2002. These accessible reaches have Coho, Cutthroat and Steelhead utilization⁹. This section of the creek is in a treed gully 100-250 m wide with rural properties and access road on the outside of the riparian area. There is one recreational trail crossing at the lower reach near the mouth.

Boulder and bedrock dominated substrates limit spawning locations. Pools are limited in number. Flow is limited (Lough and Morley, 2001). Trail access may result in quad damage to the channel and riparian. There may have been historic fish access over Triple Falls prior to logging and degradation of the jump pool crests.

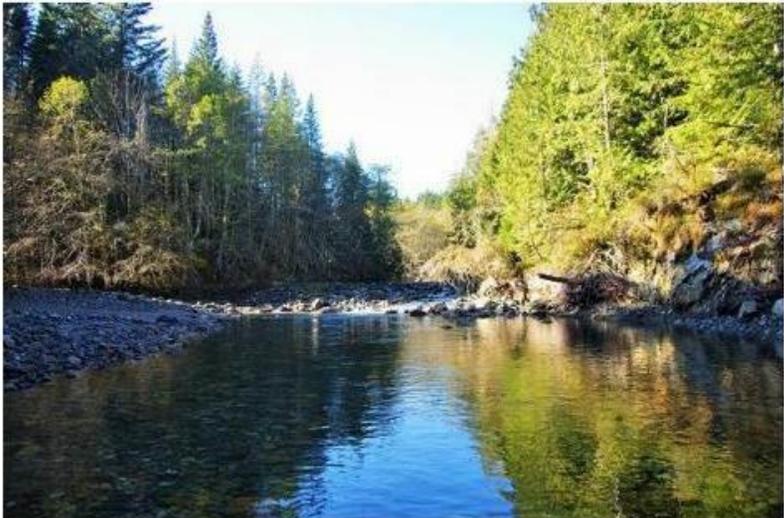
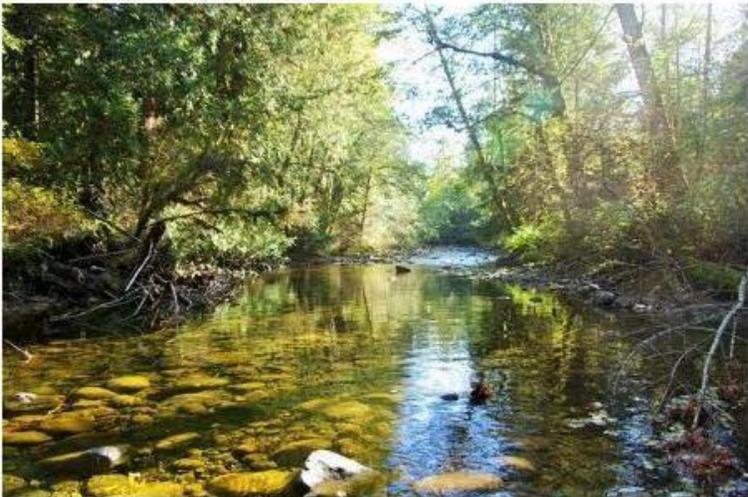
S. Eng. R. DS

This short lowest reach is wide and unconfined. Centre Creek enters at the top end of the reach. It is noted for sparse LWD, gravel deposits and lack of summer pools.

The lower reach is accessible to Chum and Coho and has plenty of spawning gravel, but it was not highly recommended by Lough & Morley (2002) for restoration due to instability. They recommend cabling standing trees as an opportunity to control loss of LWD adjacent to unstable banks. Blackman & Hurst (1988) noted 52,000 m² of the wetted habitat in Ferguson Swamp.

Lough & Morley (2002) offered similar prescriptions for the three reaches due to similar limiting factors; summer drying, lack of LWD and lack of winter refuge habitat. Lough & Morley (2002) recommend cabling standing trees, adding LWD and stabilizing the SE3 debris jam. They also suggest investigating improving the barrier at 4.5 km to access 6.0 km further habitat. Gaboury (2005) noted no high priority restoration opportunities, and Lough & Morley (2002) ranked restoration as moderate.

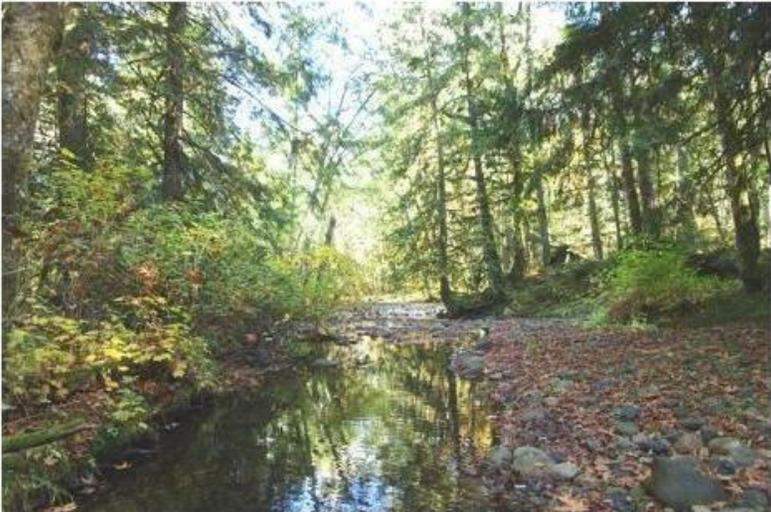
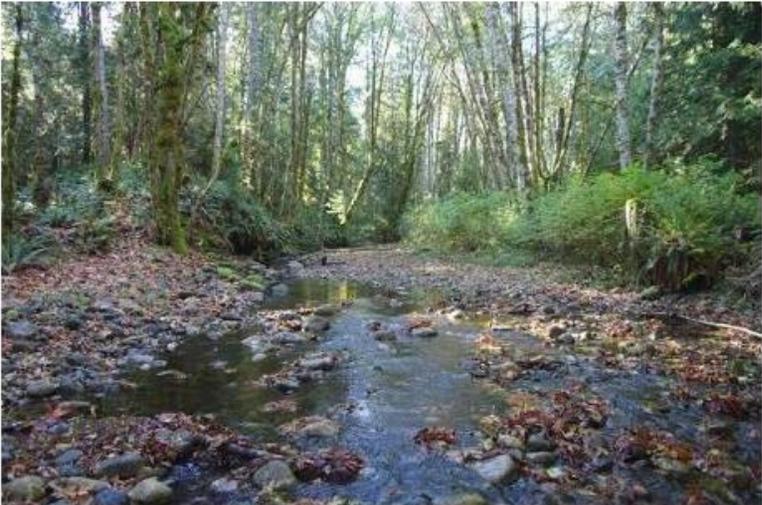
Centre Ck US

Centre Creek is the longest anadromous tributary of the Englishman River. Coho are found in this creek up to the barrier at 5.2 km (Lough and Morley, 2002). The total watershed area is 20.8 km² and has a mean annual discharge of 1.5m³/s (Lough and Morley, 2002). Centre Creek was historically logged to its stream banks and Rood (2002) noted historic channel changes from significant sediment accumulation in the 1950's has evolved to a narrower, stable vegetated channel. Four reaches were surveyed in the detailed habitat assessment, three are in the anadromous area and the fourth ended at the logging road crossing 7.0 km upstream. The MVIHES commissioned a "Detailed Salmon Habitat and Riparian Overview with Level II Prescriptions" (Warttig & Clough, 2004, 2008). The habitat summary table is presented below;

The stream channel was historically logged to its banks and the resultant changes to the channel width, sediment transport and resulting loss of habitat diversity are identified by Rood (2002) and Lough & Morley (2002). The detailed habitat assessment proved the previous overview assessments were not incorrect in their poor habitat predictions. Warttig and Clough (2004/2008) found LWD and instream cover was well below provincial fish habitat standards (Johnston & Slaney, 1996)

This long flat tributary lacks cover, pool depth and habitat complexity throughout its length. The Restoration Plan (Warttig & Clough, 2004, 2008) identified opportunities for the entire anadromous length with template prescriptions. The work has been almost annual since 2004 and more is planned in 2013 by the MVIHES and the Pacific Salmon Foundation Community Salmon Program.
